Accelerator Department
BROOKHAVEN NATIONAL LABORATORY
Associated Universities, Inc.
Upton, N.Y.

AGS DIVISION TECHNICAL NOTE

No. 70

DETERIORATION OF ELECTRICAL INSULATION
OF MAIN MAGNET COILS FROM MAGNET G-1

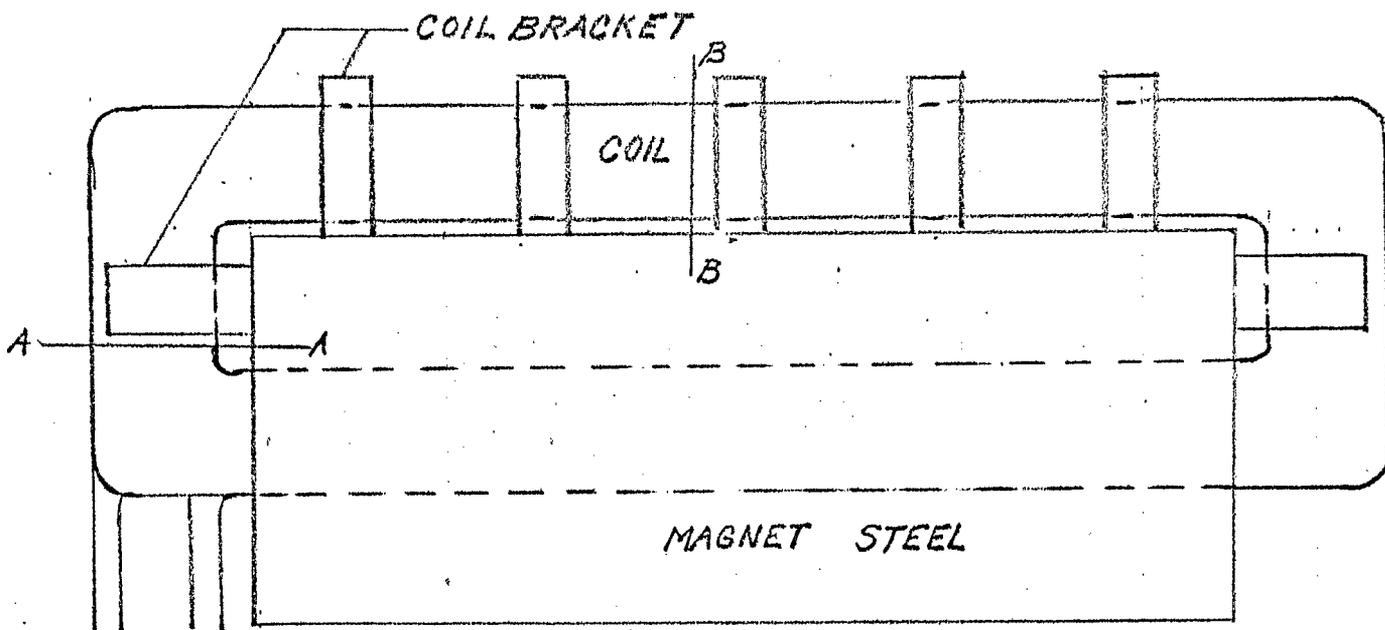
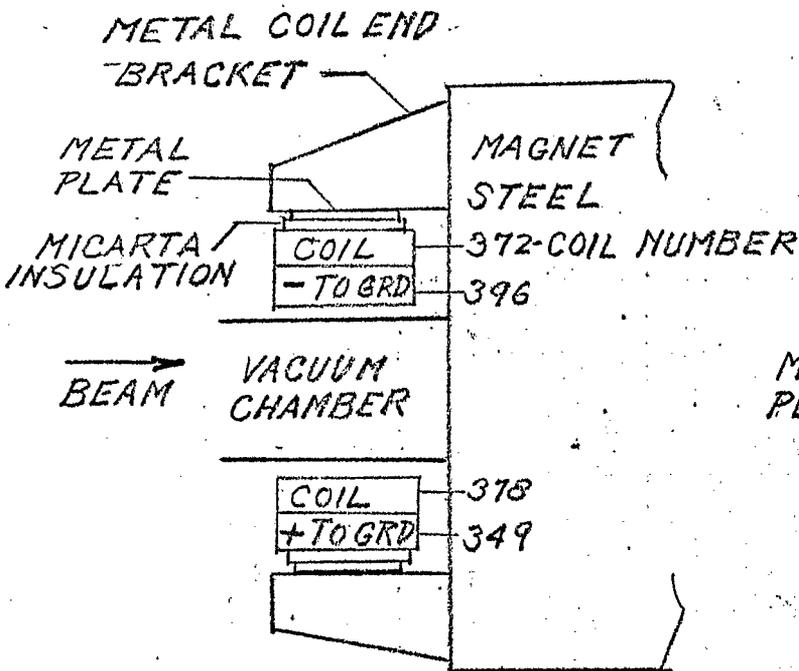
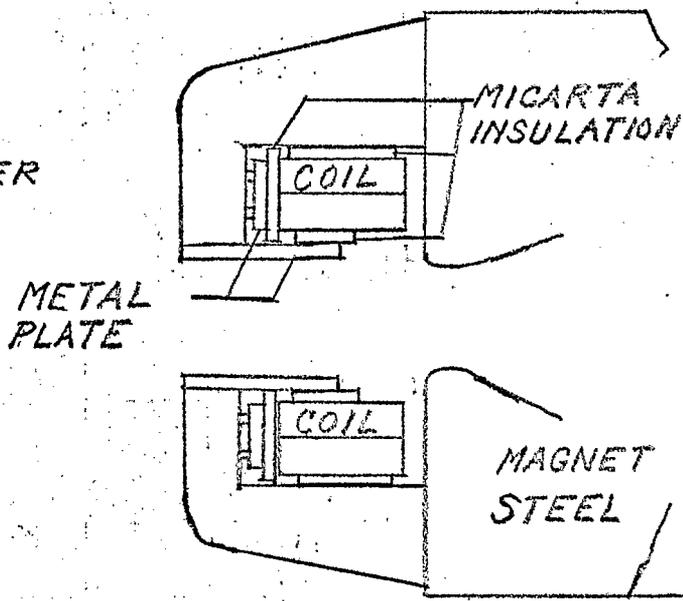
SUBJECT SCHEMATIC COIL MOUNTING - MAIN MAGNET - MICARTA INSULATION SPACERS

A sketch of the coil assembly on the magnet is shown in Fig. 1. Photographs of the burned areas are shown in Figs. 2, 3, 4, 5, 6 and 7. (The coil numbers are shown on Fig. 1.)
