Accelerator Department
BROOKHAVEN NATIONAL LABORATORY
Associated Universities, Inc.
Upton, New York

AGS DIVISION TECHNICAL NOTE

No. 99

SIEMENS POWER SUPPLY MOTOR-GENERATOR SET
MOTOR ROTOR FAILURE

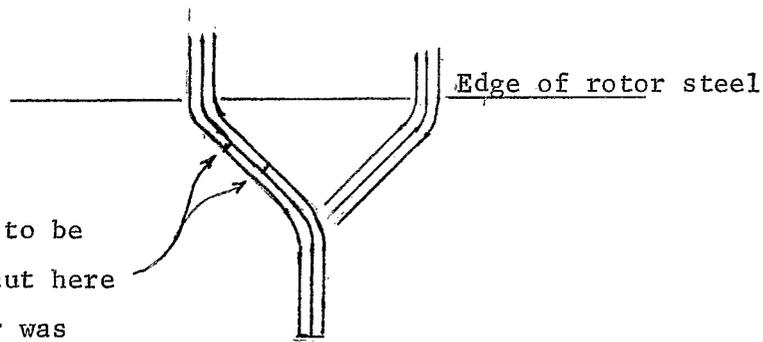
The coil to be repaired was cut here and new copper was

brazed with staggered joints as shown. The brazed joints were then ground to bar size. The repair work on the coil was completed on this day and it is an excellent job.

The repair will be done by brazing using fifteen percent (15%) silver.

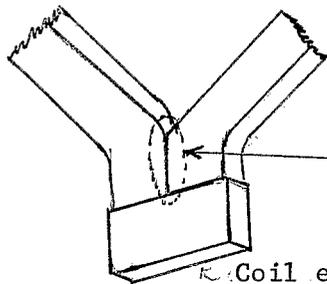
Coil end cap insulation

The coil end connection has a small space between coils in this area which allows dirt to collect and shorten the creepage path to conductors.

under the end cap insulation. The major portion of the fault was in this area. All end cap insulation will have this space filled with an epoxy and the complete area will be insulated with glass tape and epoxy.

All coil end cap insulators were filled with epoxy in addition to the space between coils and each connectors. They were then glass taped and epoxyed. The epoxy used to fill the end caps is Astro Chemical Co., Schenectady, New York, "Barco Bond" two part mix equal of each. The glass tape is held in place with Scotch Grip #1300L adhesive.

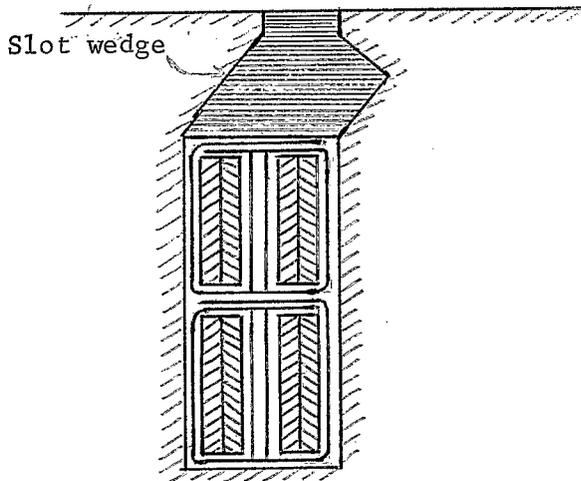
The old slot liner insulation was folded over at the top of the bottom coil and a new U shaped liner insulation was installed with the upper coil.

The twelve upper coils were installed in the slots and wedges. The spare coils and new wedges were used.

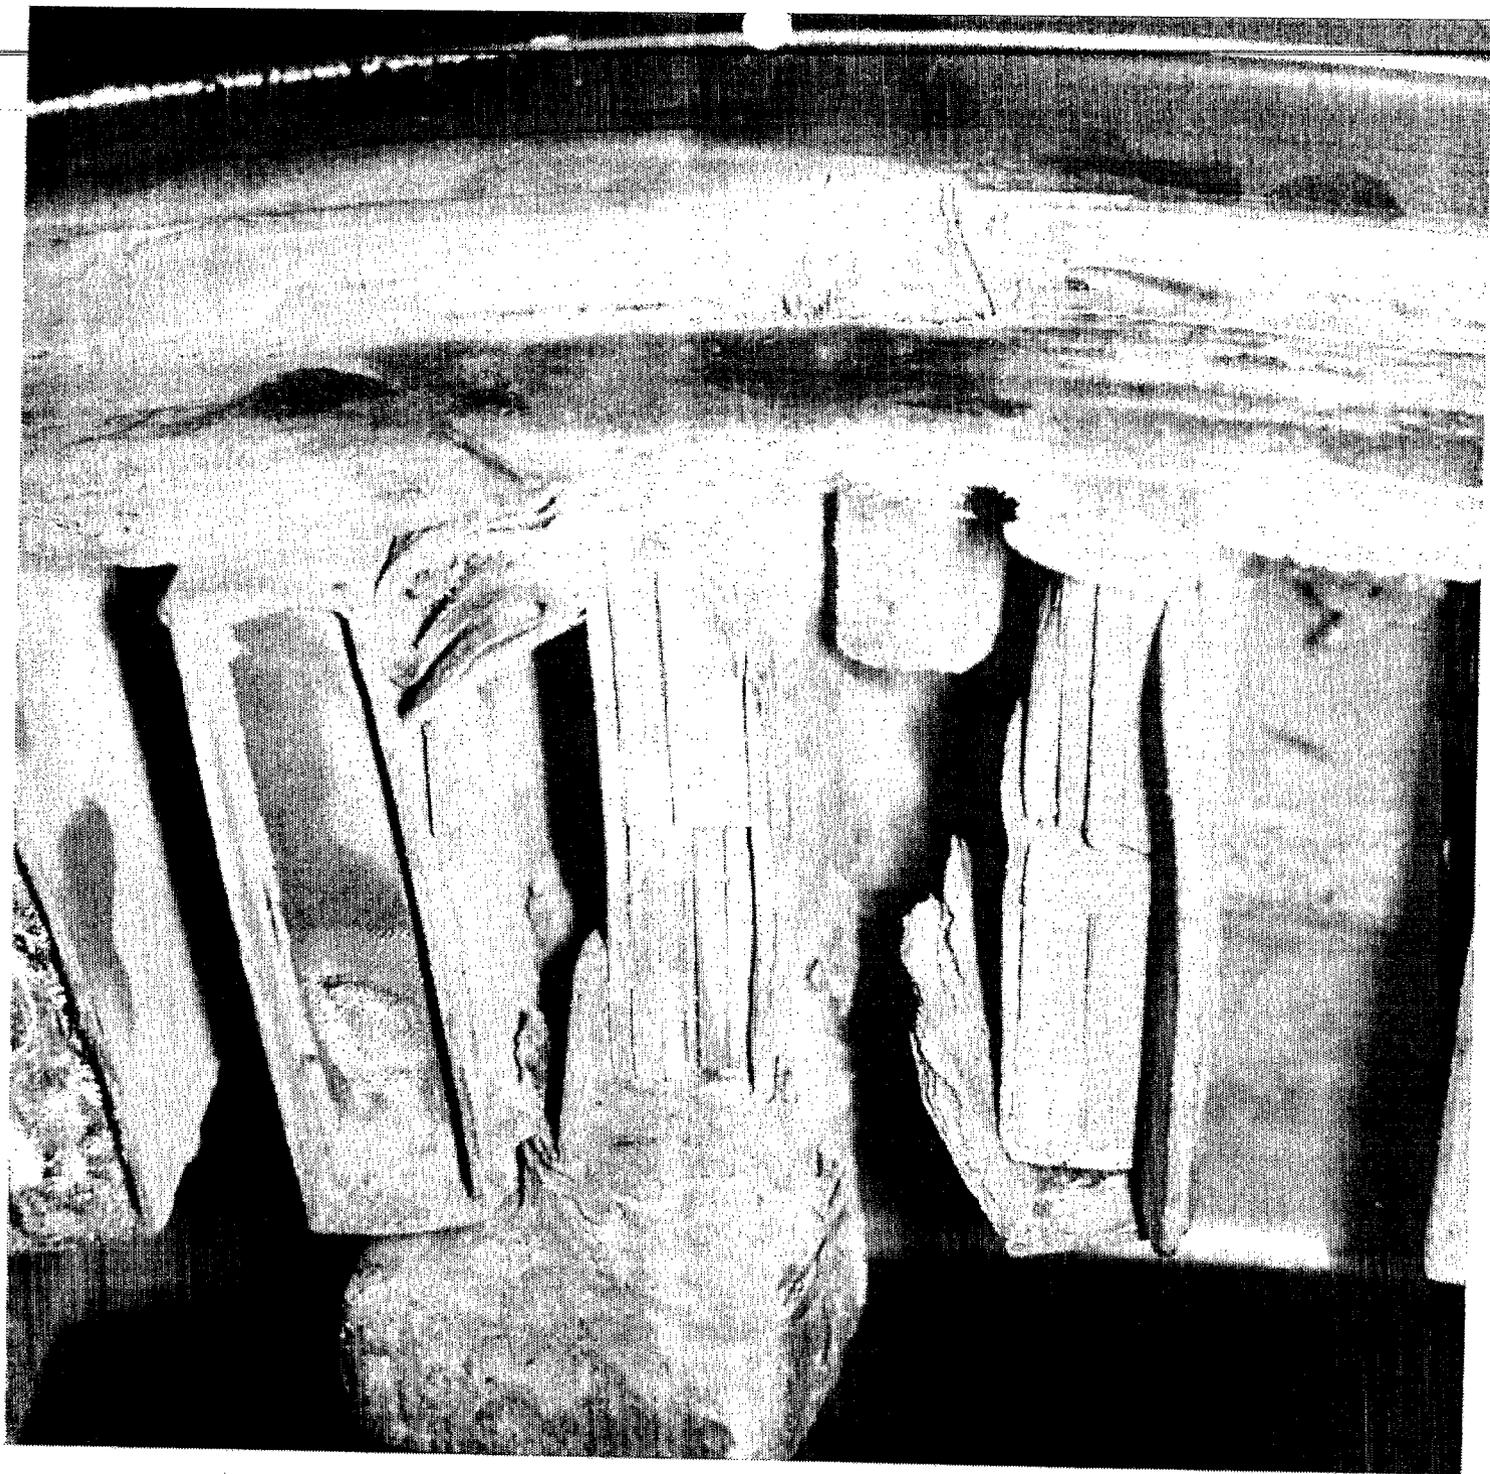
Fig. 2

After removing the slip-ring cover and the motor end shields, it was found that one or two rotor winding end connections and the rotor to slip-ring connections were severely burned. Figures 2 to 6 show different views of the external damage at the rotor winding end connections, and Figs. 7 to 9 show the physical damage at the rotor to slip-ring connections.

When the fault occurred, the heat generated by the fault melted the solder which was thrown outward centrifugally on the end turns of the stator coils and inside the motor end shields. No damage was done to the stator coils. Extensive arc erosion took place on one of the rotor half coil ends. The copper evaporated. The fault was phase to phase. The area of the damage is shown circled in red on Siemens drawing number TRA-W 1827/1. At the rotor winding to slip-ring connections, the arc occurred from the bolted joint (rotor winding connection bar to slip-ring bars) to the shaft and slip-ring assembly guard ring which is at the same potential as the shaft. The heat generated by the arc melted the connection solder which was thrown out centrifugally to the inside of the outer motor end shield.

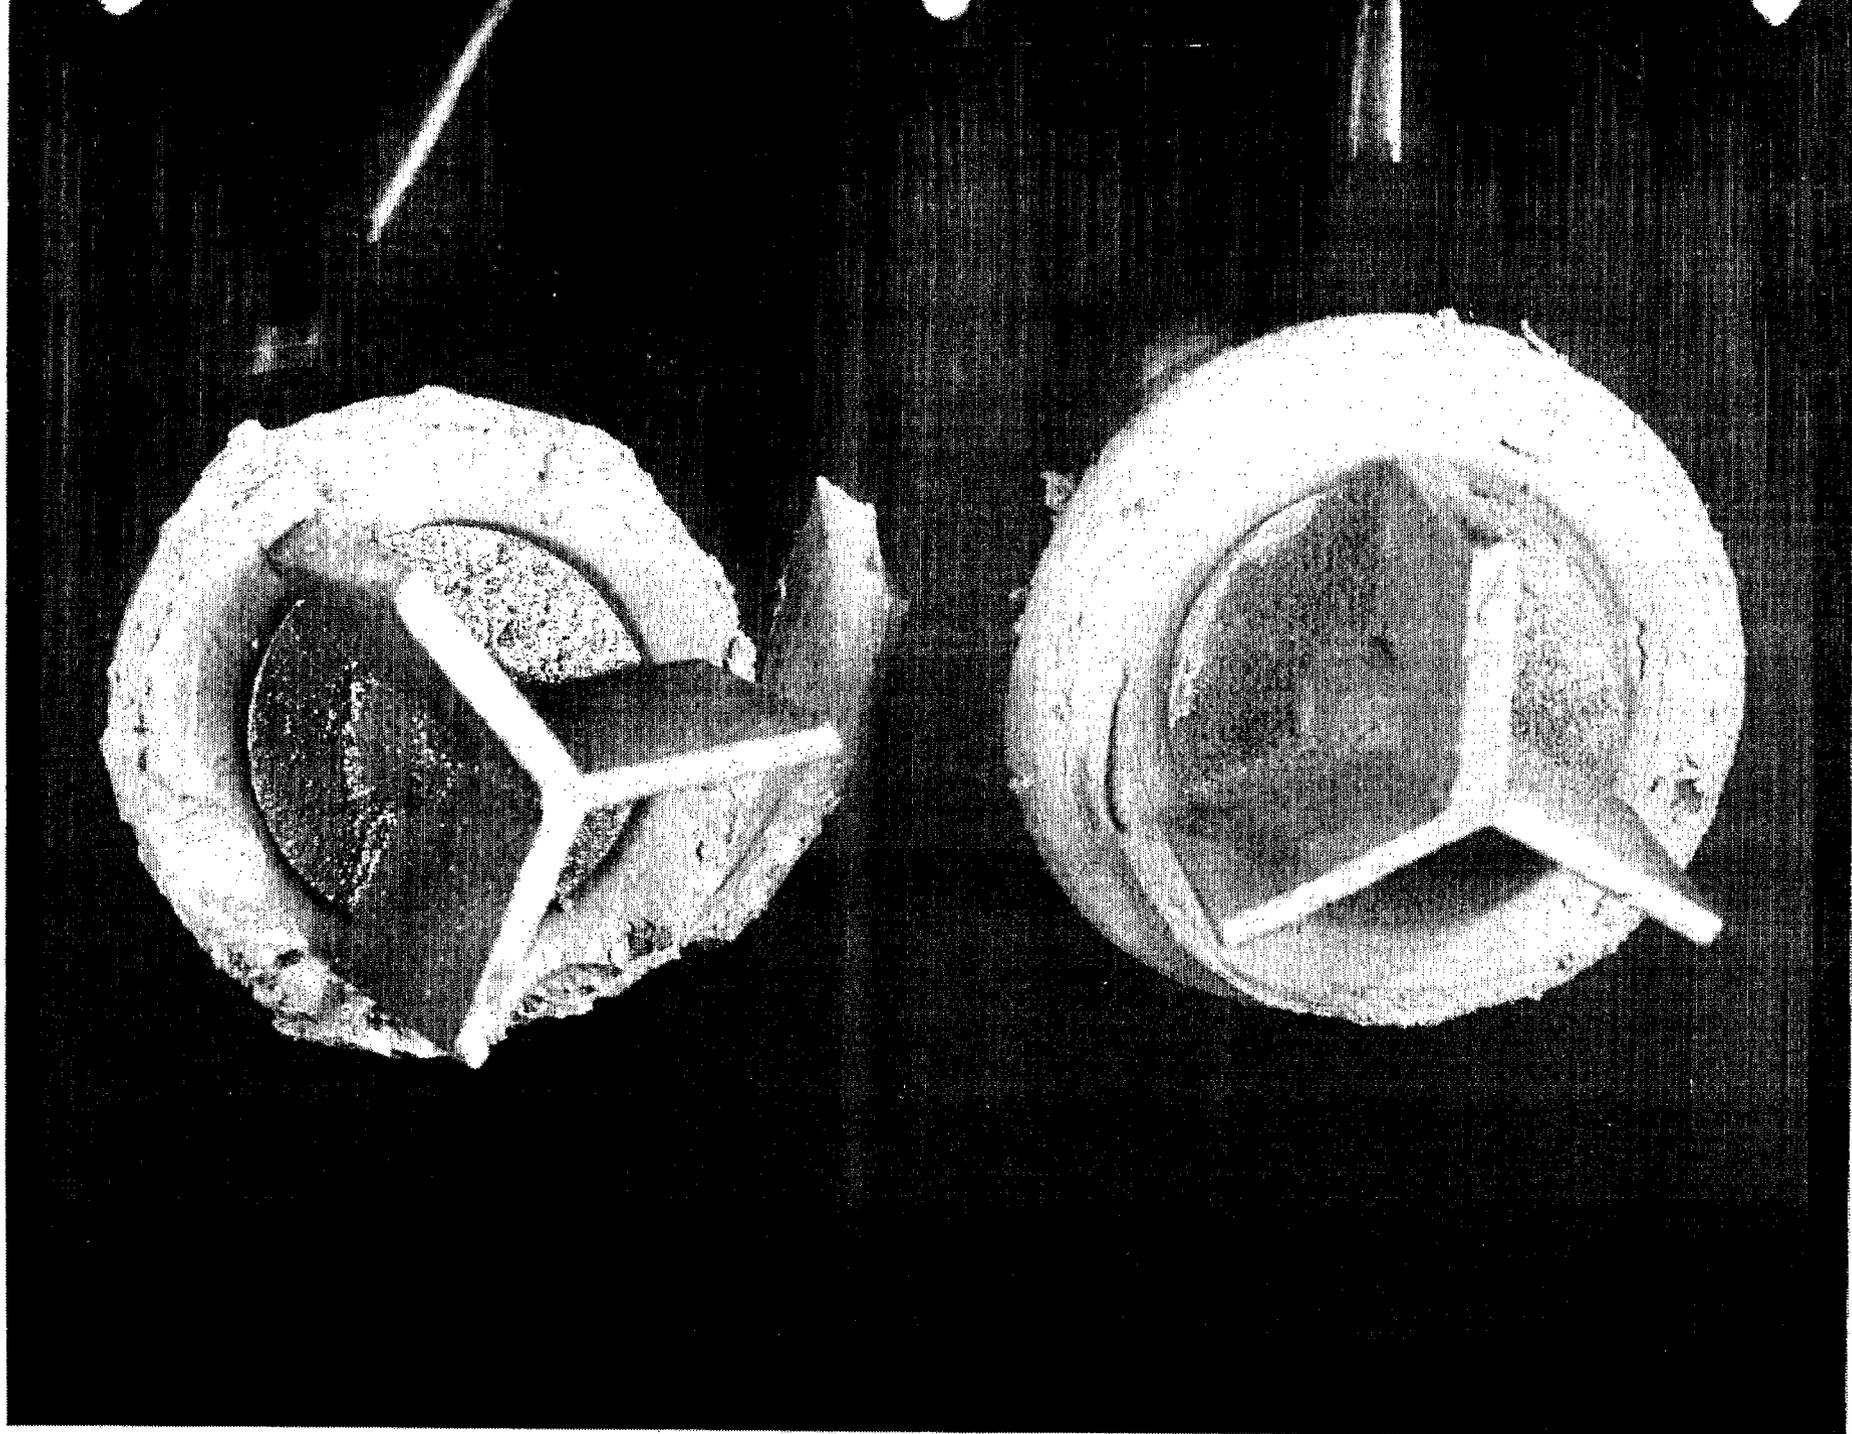
Fig. 10

The pumps were disassembled and thoroughly examined for signs of wear or component failures and none could be found. Each pump suction line has a foot valve (check valve) installed at the lower end of the pipe line near the bottom of the oil tank. See Siemens drawing number 2D8.6701-167338 coordinate B5. These check valves were disassembled. It was found that the check mechanism seal had deteriorated. See Figs. 10 and 11. The material used to seal at the valve seat (not shown) was some type of rubber which had become spongy, distorted, and eroded in the case of pump #2 check valve where the flow was not impeded when tested. In the case of pump #1 the seal material was so bloated as to impede the proper operation of the valve and thereby to restrict the normal flow of oil.

Since pump #1 and #2 are well down into the tank, and therefore self-priming, the suction line check valves were completely removed. The check valve at the lower end of the shaft-driven pump suction line exhibited the same problem as the others in that the seal material was spongy and bloated to the point that it seriously restricted the normal flow. The seal material is very evidently not compatible with the lubricating oil. This oil is Mobil DTE medium grade oil without any inhibitors. Since this check valve must hold

fifteen feet of oil to prevent the loss of charge of oil for the shaft-driven pump, it was repaired using Buna-N synthetic rubber material to replace the defective seal material.

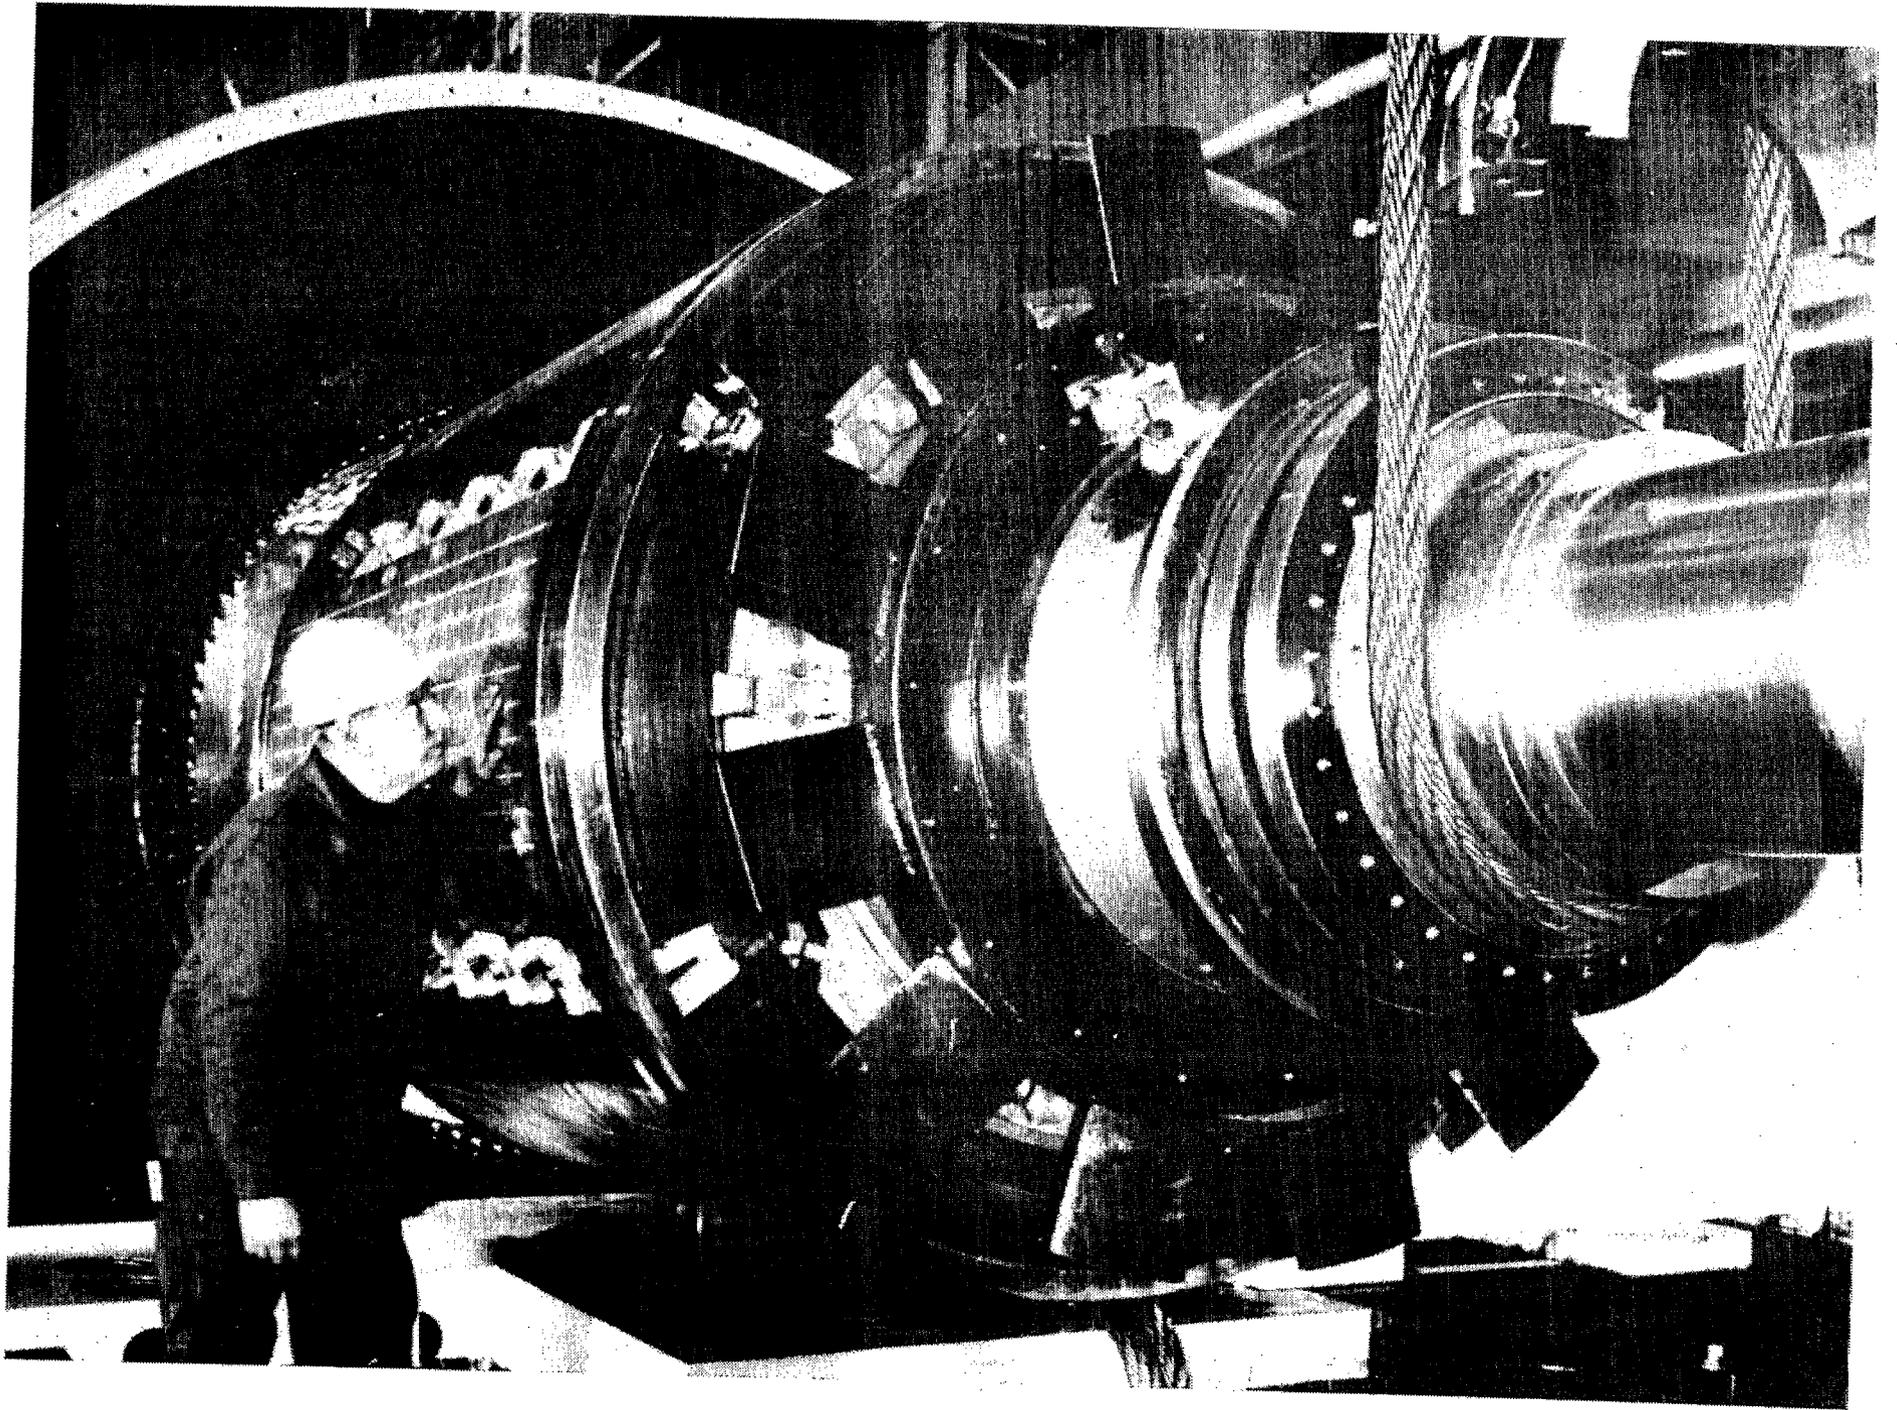
Fig. 12

Inspection of the AGS generator rotor showed the same condition. See Fig. 12, generator rotor, and Siemens drawing number 1D1.1384-156656, field coil brace. In the photograph, the field coil braces (light color) are shown between the poles. There are six braces between each of the six poles. As shown on the field coil brace drawing, one bolt retains the brace. The bolt head is locked by a lock plate to prevent it from turning. In turn the brace compresses insulation blocks onto the field coils.

During normal operation, the poles expand thermally due to the field pole current and elastically due to the high centrifugal force. These compress the insulation blocks at the field coil braces. With continuous operation, the insulation blocks become thinner requiring the tightening of the field coil brace retaining bolts periodically. Since these retaining bolts are not easily accessible while the rotor is inside the stator, the rotor must be pulled out to accomplish the tightening.

The field coil brace were tightened down and the retaining bolts were

torqued to 150 foot-pounds. The generator rotor was rigged back into the stator and completed Wednesday, September 20.
