**Fire Hazard Analysis
Building 911
Accelerator Department Support Facility**

Brookhaven National Laboratory

Date of Last Survey: August 1990
Date of Report: September 30, 2006

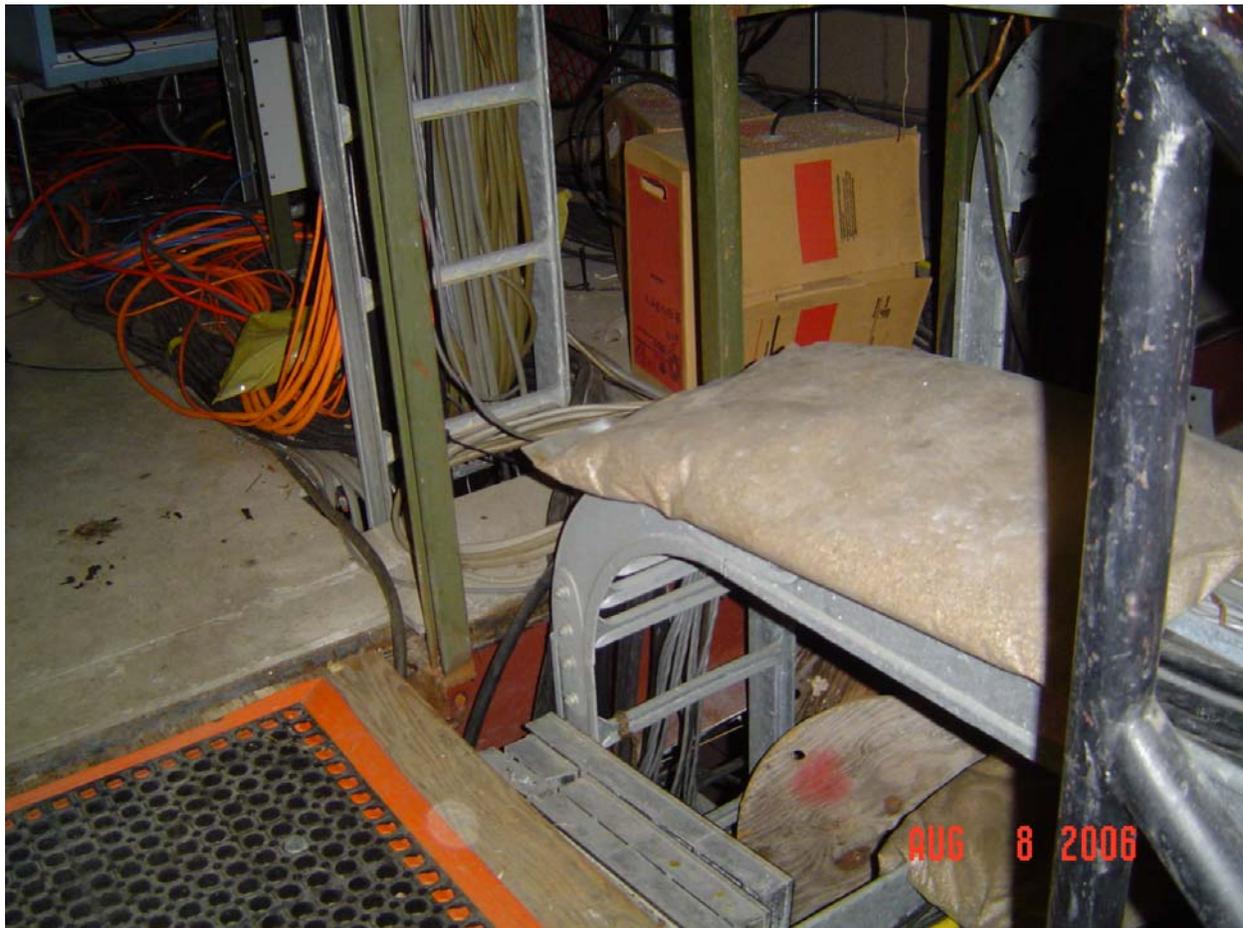
Photograph 1

Cable penetrations through the Second Floor assembly between the Main Terminal Room 115 and Terminal Room 222 are not adequately protected with firestopping. The hazardous products of combustion from a fire in the Main Terminal Room could spread through the unprotected penetrations into Terminal Room 222.

Polyethylene bags containing vermiculite are positioned on cables on the floor of the Main Terminal Room (See Photograph 1). Based on communications with the accompanying facility personnel, the vermiculite bags are intended to resist fire spread along the cables. The bags are not listed for such use. UL-listed or FM-approved firestopping should be provided to limit fire spread into adjacent spaces (See **Recommendation HAI-06-911-03**).

Recommendation HAI-06-911-03 (LSC90-911-6): Seal unprotected openings between the Cable Tunnel and the Pedestrian Tunnel with a UL listed or FM approved material having a minimum of 1-hour fire resistance rating.

the walls and floors should be fire stopped or sealed in accordance with the building code (**See Recommendation HAI-06-911-03**).
