Booster/AGS Ring Power Supply Systems
Group Procedure EPS-S-016
Revision 00

Trouble: Sta II P transformer---Rack LC-1 (Pressure/Vacuum Gage) (Relay C11d12 energized)

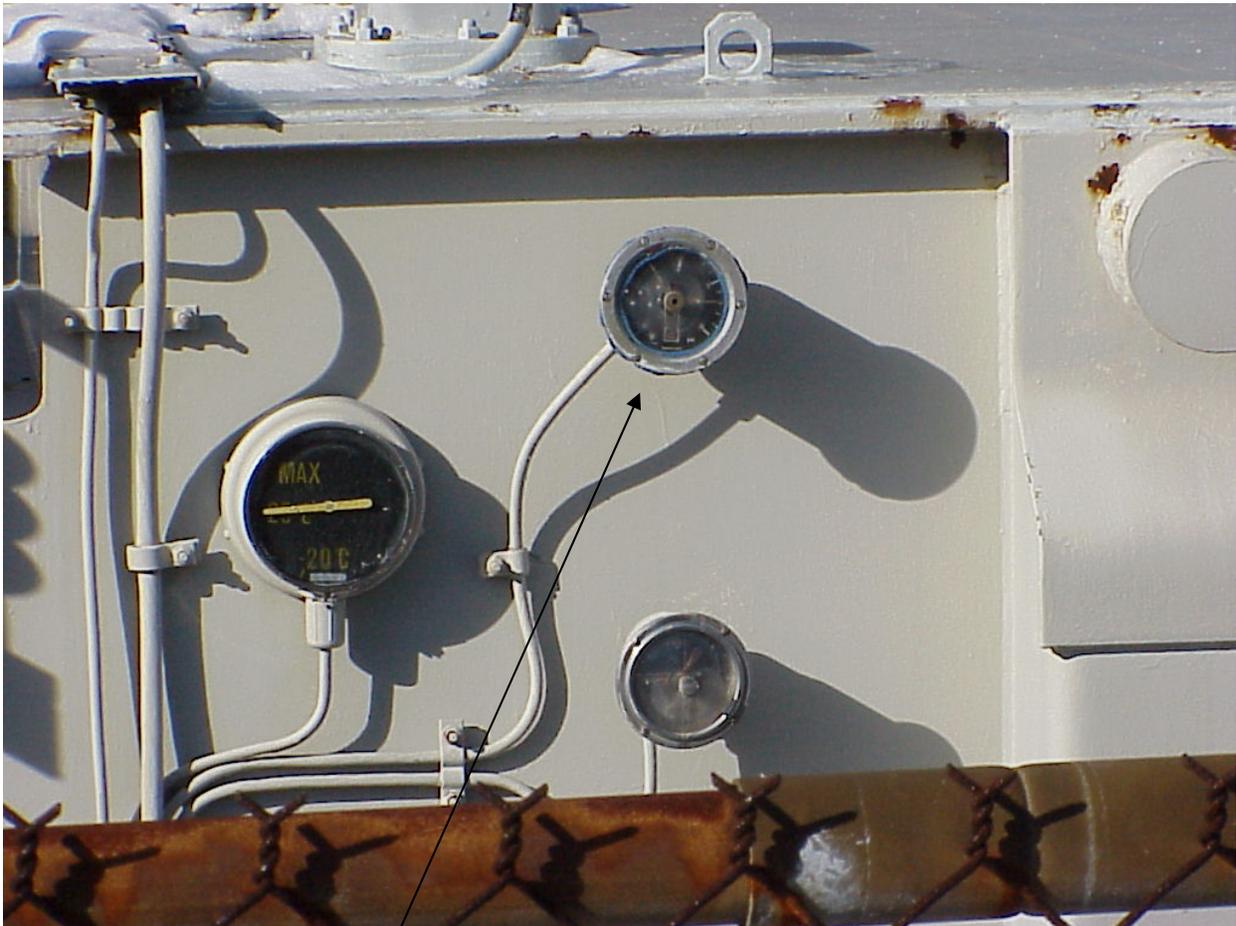
Interlock originates on Sta. II P Bank Transformer (east side of tank)

- 1) Go outside and make sure gauge is not over-pressured or gone into vacuum (setpoints are 2.5 vac and 7 PSI pressure) also note if gauge is full of moisture????_____yes
_____no
- 2) If there seems to be no problem noted: tap the side of this gauge and see if interlock clears. If so turn back on.
- 3) If this interlock becomes a nuisance and we are sure there truly is no trouble with pressure or vacuum. We were given permission to disconnect wire in LC-1 terminal 127 so this interlock does not continue to trip us but we must monitor the outside gauge every 30 min. making sure pressure is still around 1 psi. This gauge can be read from the outside of cage area.
