Booster/AGS Ring Power Supply Systems
Group Procedure EPS-S-025
Original Issue Date: 10/20/03
Revision 00

**C-AD MOTOR GENERATOR (SIEMENS)
MAINTENANCE**

June 23rd through August 31st, 2003,
after 4,784 hours of run time

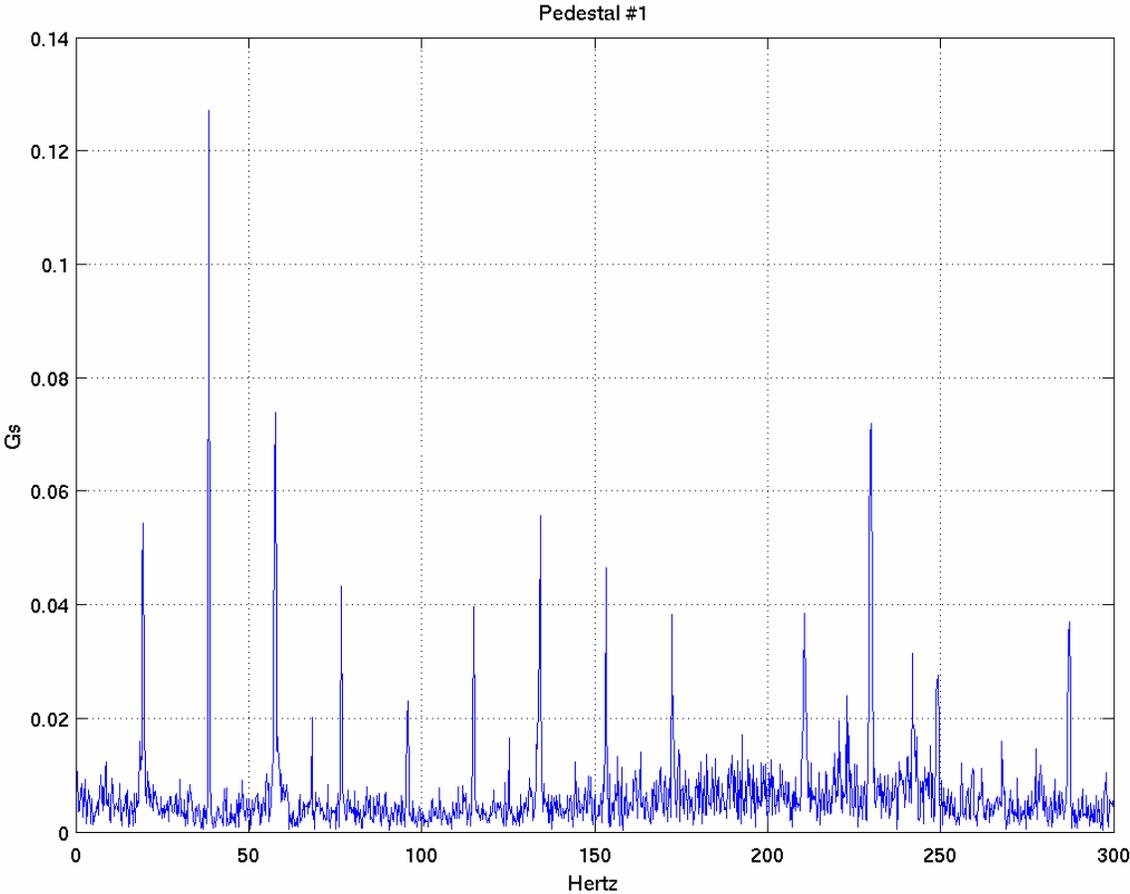
Attachment # 1a

- A. The vibration measurements were taken before the machine was shut down, and the results can be seen in attachments #1a, 1b, 1c
The signature of the targeted points (pedestals 1,2 and 3) was similar to the one found by E in 2002
- B. The coast-down time was: **1h and 17min.**
- C. The newly designed “Laser Protection and Access Platform” was installed. An additional secondary platform was installed on the West side of the Generator.

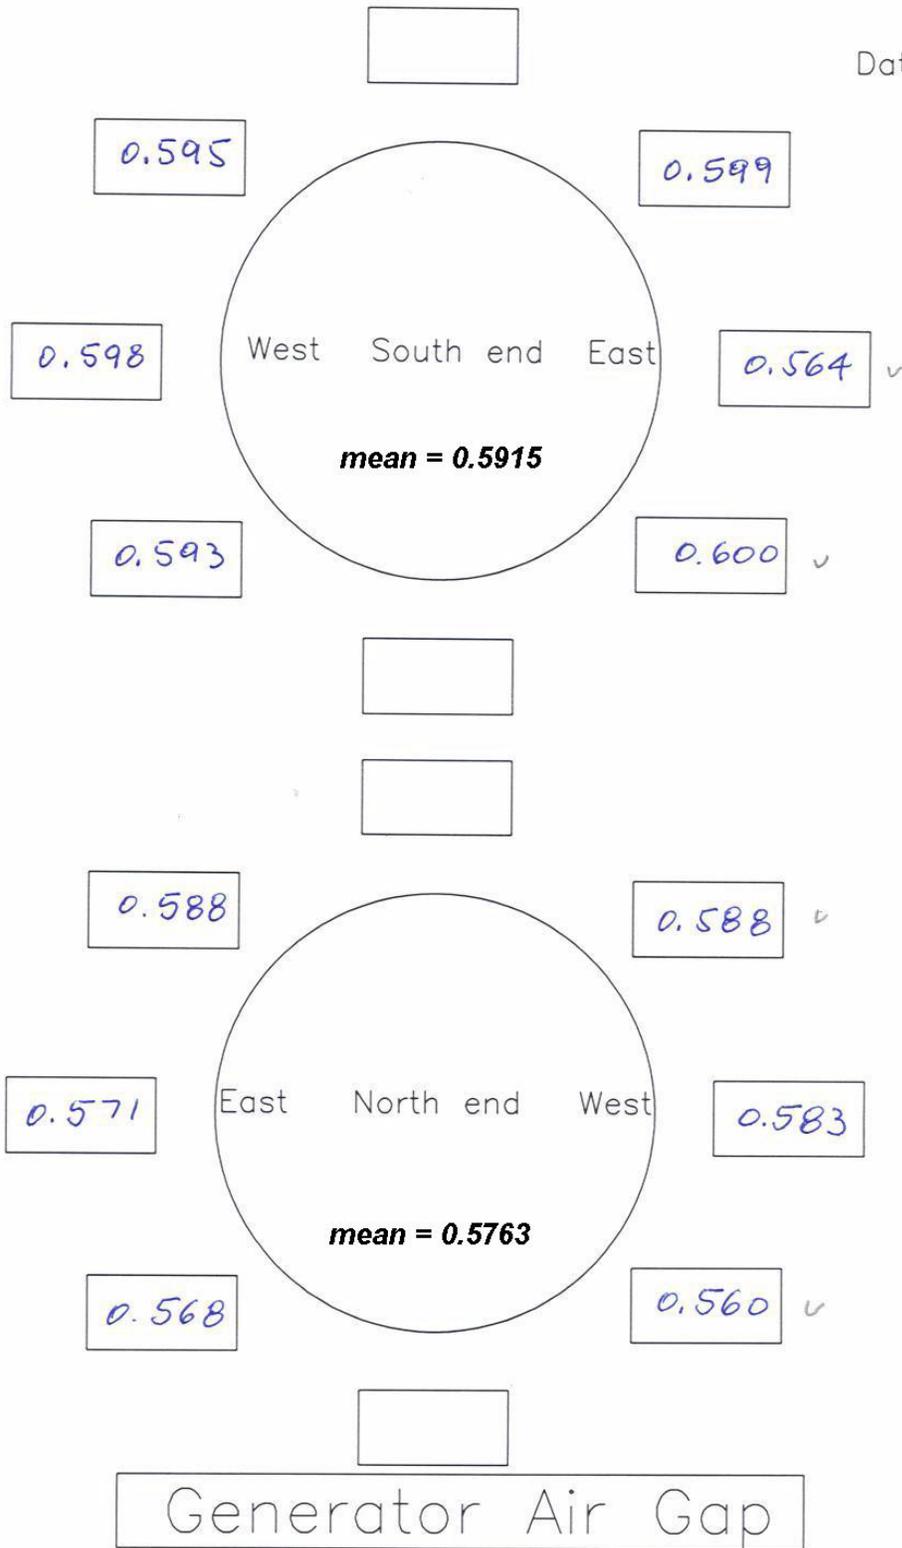
Attachment #2

a) The Generator’s Air Gap was checked and the variation was found to be as follows:

South mean = 0.5915; variation: +1.48%, -4.65%

North mean = 0.5763; variation: +1.17%, -2,83%

(GE results from 2002 were showing variations between +4.50% and –2.76%)

Since the Air Gap was within tolerance limits and close to last year’s results, the stator was not moved.

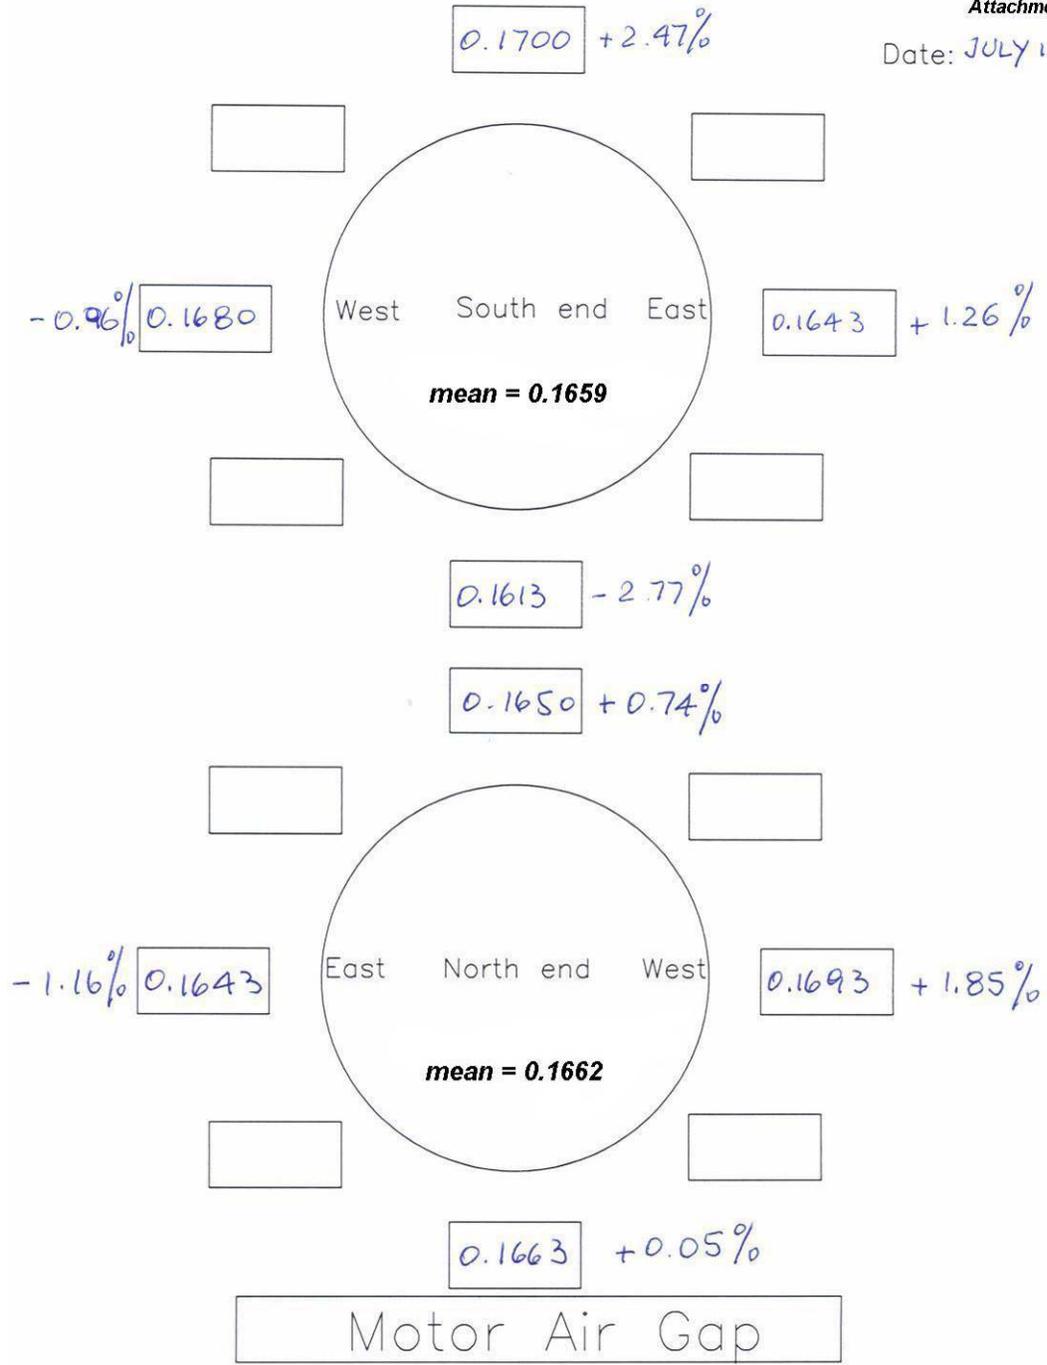
Attachment #3

- b) The Motor's Air Gap was checked and it was determined that the stator has to be moved West by 0.015".

South mean = 0.1659; variation: +2.47%, -2.77%

North mean = 0.1662; variation: +1.85%, -1.16%

(GE results from 2002 were showing variations between + 4.5% and -2.70%)

A small size magnetic drill was purchased and used with a "Variac" device inserted in the main motor electric supply line (not in the magnet line) to lower the RPM of the drill in order to improve the texture of the reamed surface. (The fact that the motor's stator again moved East-ward was attributed to the rough texture of the pins' holes, which were reamed by hand in the past).

Note: New reamers were fabricated for the tapered and straight pins and consequently new pins were fitted into the holes.

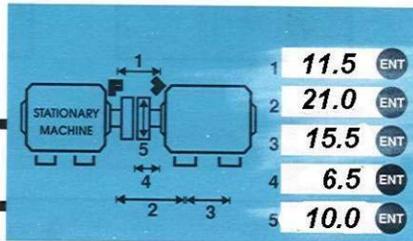
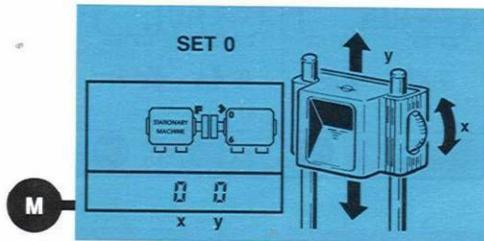
With the coupling separated by 1/8" and with the upper bearing covers off, an alignment measurement was performed using the "Optalign" device.

The machine was found to be very well aligned within 0.50 mills on all the mandatory points. (The indicated tolerance is +/- 0.001"). Please see Attachment #4

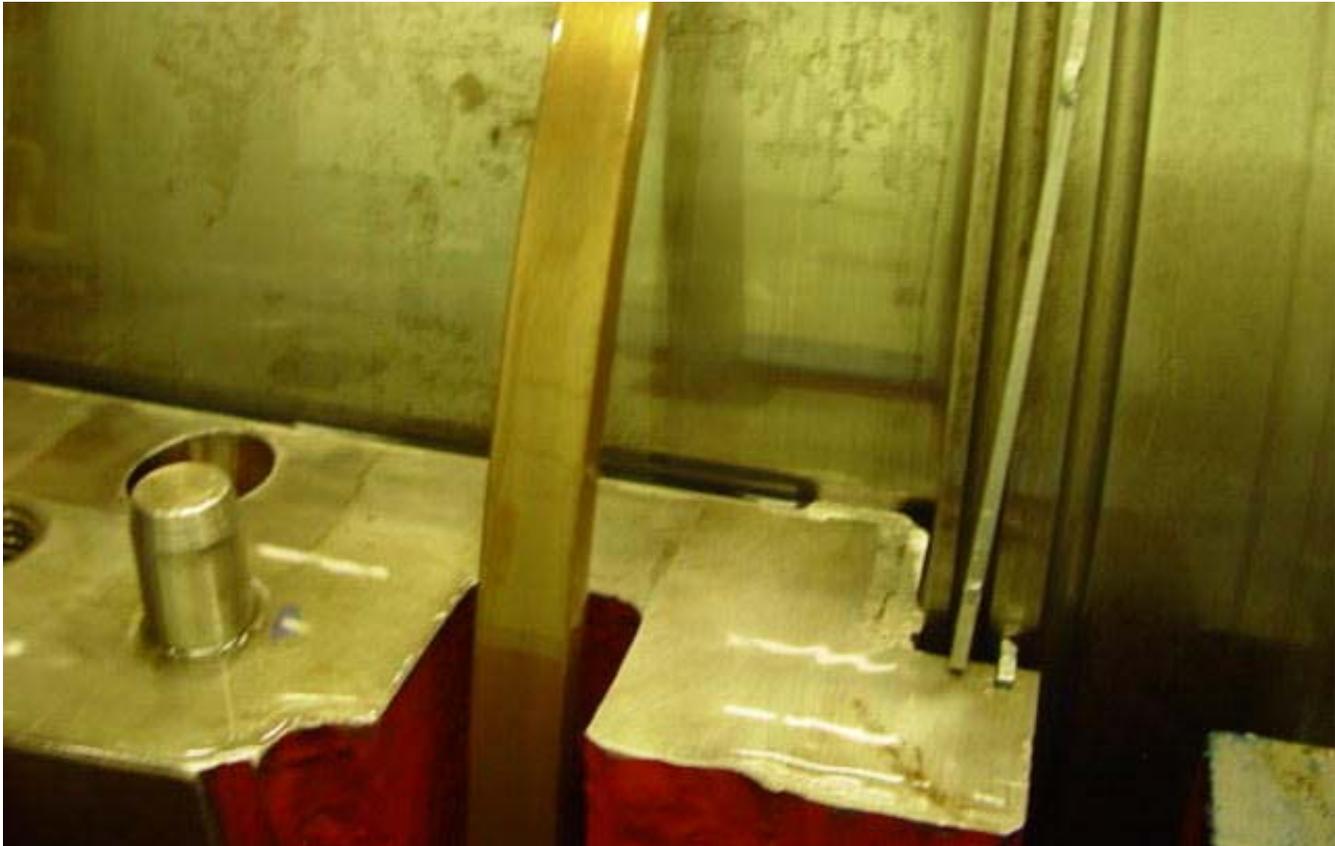
Attachment #5

The lower part of the journal bearings -that was held inside the lower bearing during this maintenance period -were found slightly oxidized. The spots were cleaned with 3M cleaning pads. Please see attachments # 5, 6, and 7 showing the journals before cleaning.

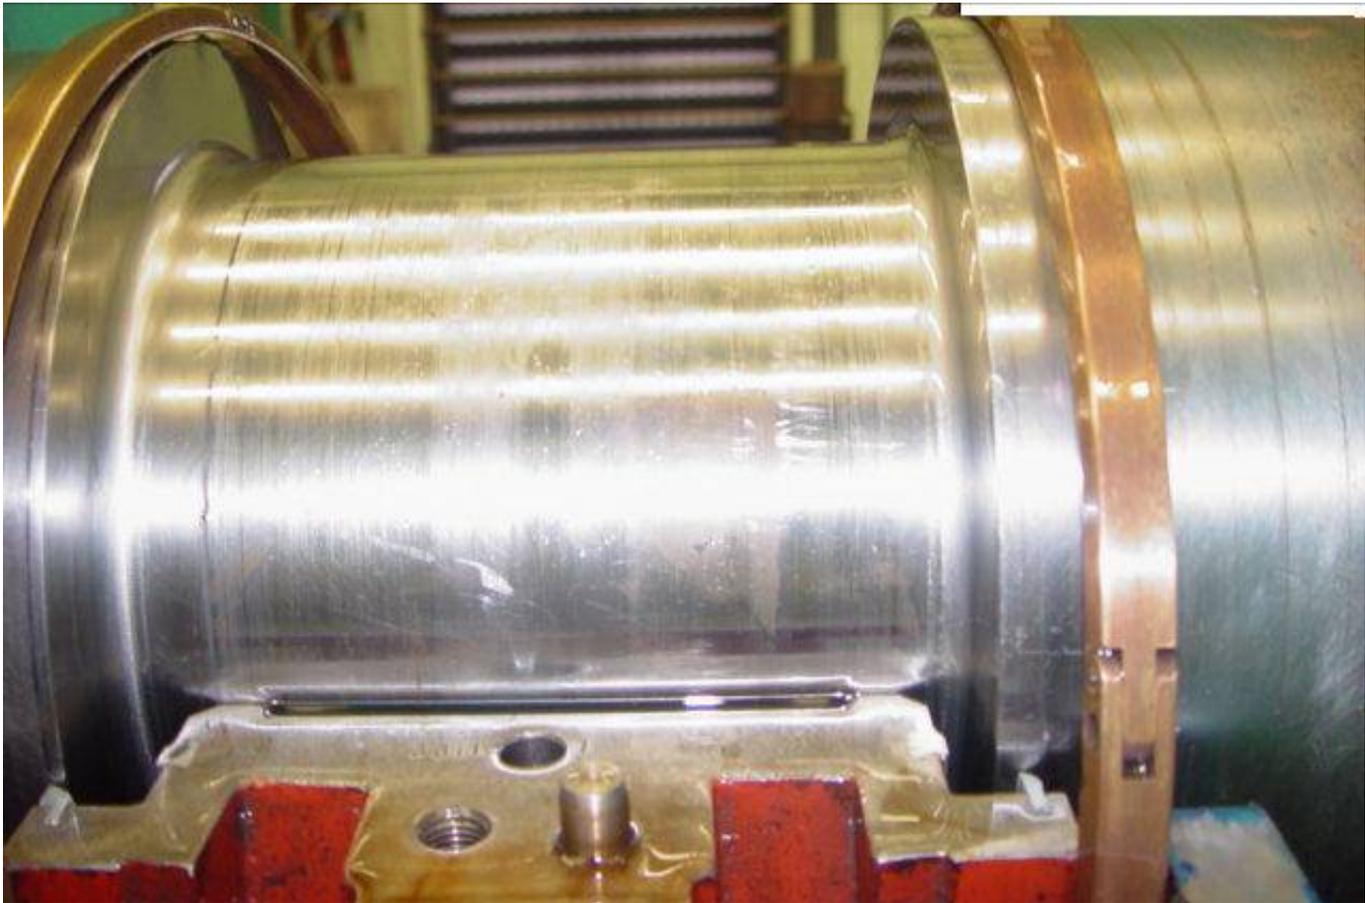
Attachment #8 shows a typical picture of one of the journal bearings after cleaning.

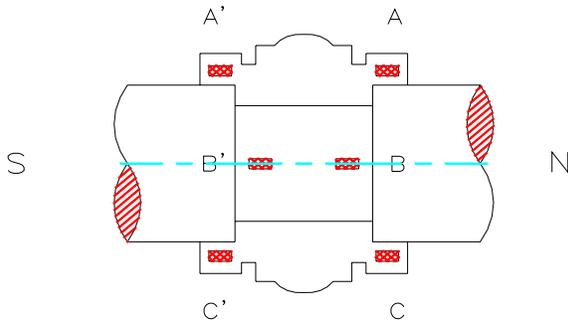
Attachment #9

Pedestal # 1 Lead crush test results

$$\text{Clearance @ B is: } B - \frac{A + C}{2} = 0.0393 - \frac{0.0160 + 0.0103}{2} = 0.0262" = 0.664\text{mm}$$

$$\text{Clearance @ B' is: } B' - \frac{A' - C'}{2} = 0.0360 - \frac{0.0160 + 0.0090}{2} = 0.024" = 0.609\text{ mm}$$

Since the Absolute Maximum Benchmark is: 0.9mm

@B location: 0.664 < 0.9 OK

@B' location: 0.609 < 0.9 OK

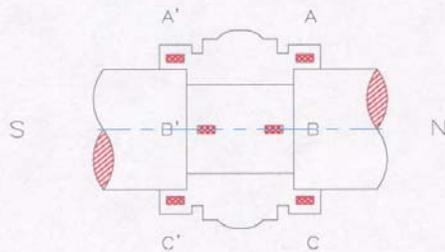
Attachment #10

Pedestal # 2 Lead crush test results

$$B - \frac{A+C}{2} = 0.04125 - \frac{0.0135+0.0115}{2} = 0.0263" = 0.667mm$$

$$B' - \frac{A'+C'}{2} = 0.0400 - \frac{0.0145+0.0130}{2} = 0.0263" = 0.667mm$$

Since the Absolute Maximum Benchmark is: 0.9mm

@ B and B' location 0.667 < 0.900 OK

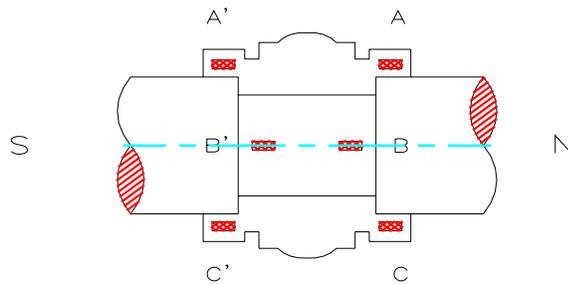
Attachment #11

Lead crush test results

Clearance @ B is: $B - (A/2 + C/2) = 0.010 - (0.010/2 + 0.02375/2) = 0.004875'' =$
0.124mm

Clearance @ B' is: $B' - (A'/2 + C'/2) = 0.010 - (0.010/2 + 0.0230/2) = 0.0065'' =$ **0.165mm**

Benchmark to be used for Max. Clearance is:
 0.1% of Shaft Diameter that is: 0.249mm

@ B location: 0.124 < 0.249 OK

@ B' location: 0.165 < 0.249 OK
