Foil change in BTA on 7/10/2008

C. J. Gardner and P. Thieberger

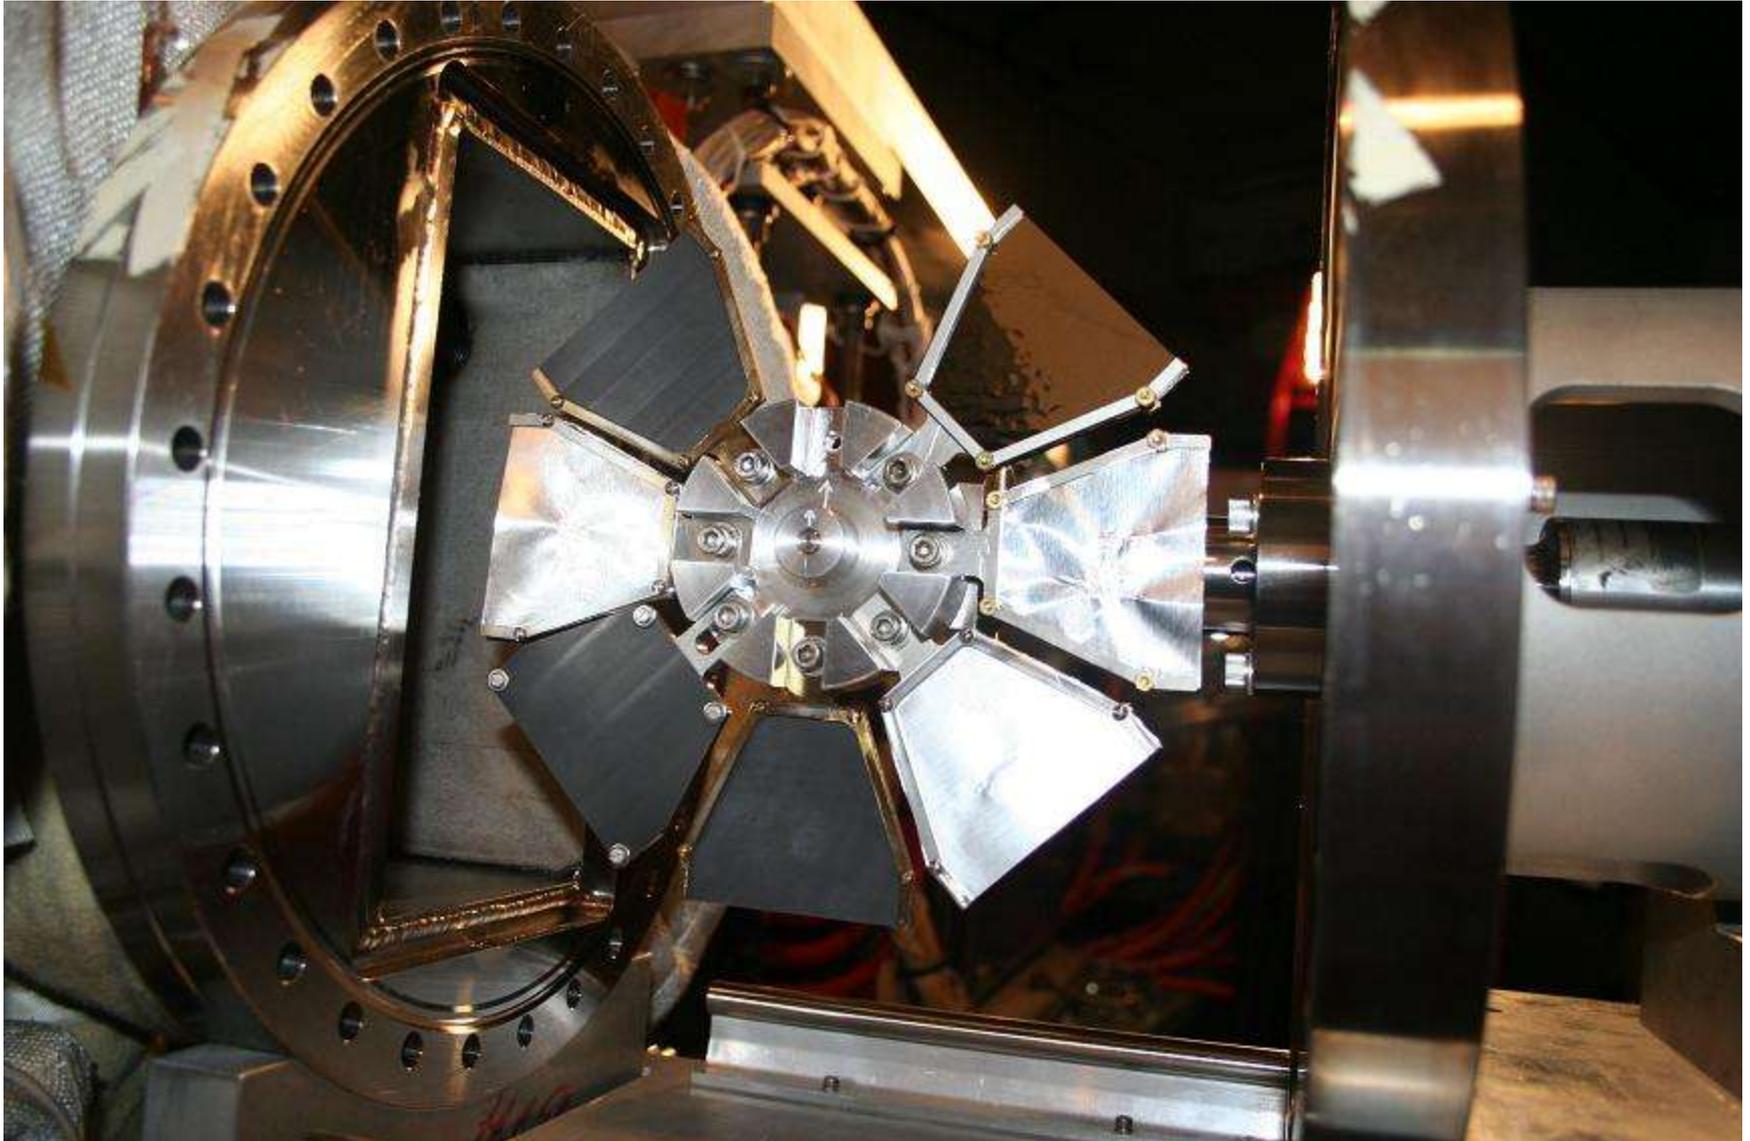
Foils #7 (right) and #3 (left) where used in last gold run

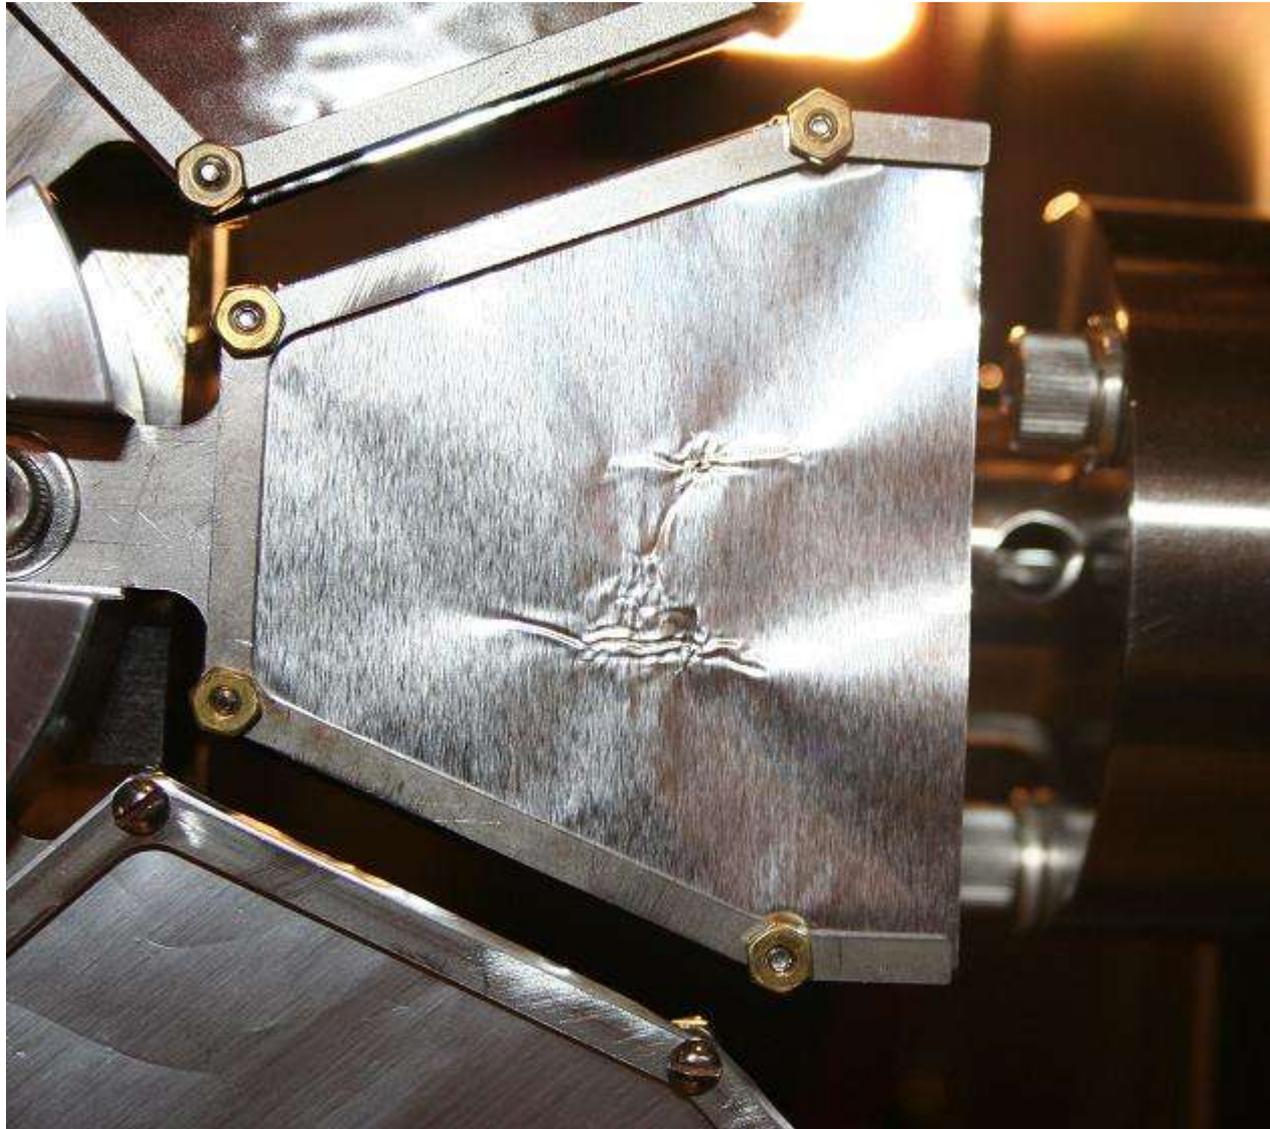
Foil #7 – Closer view

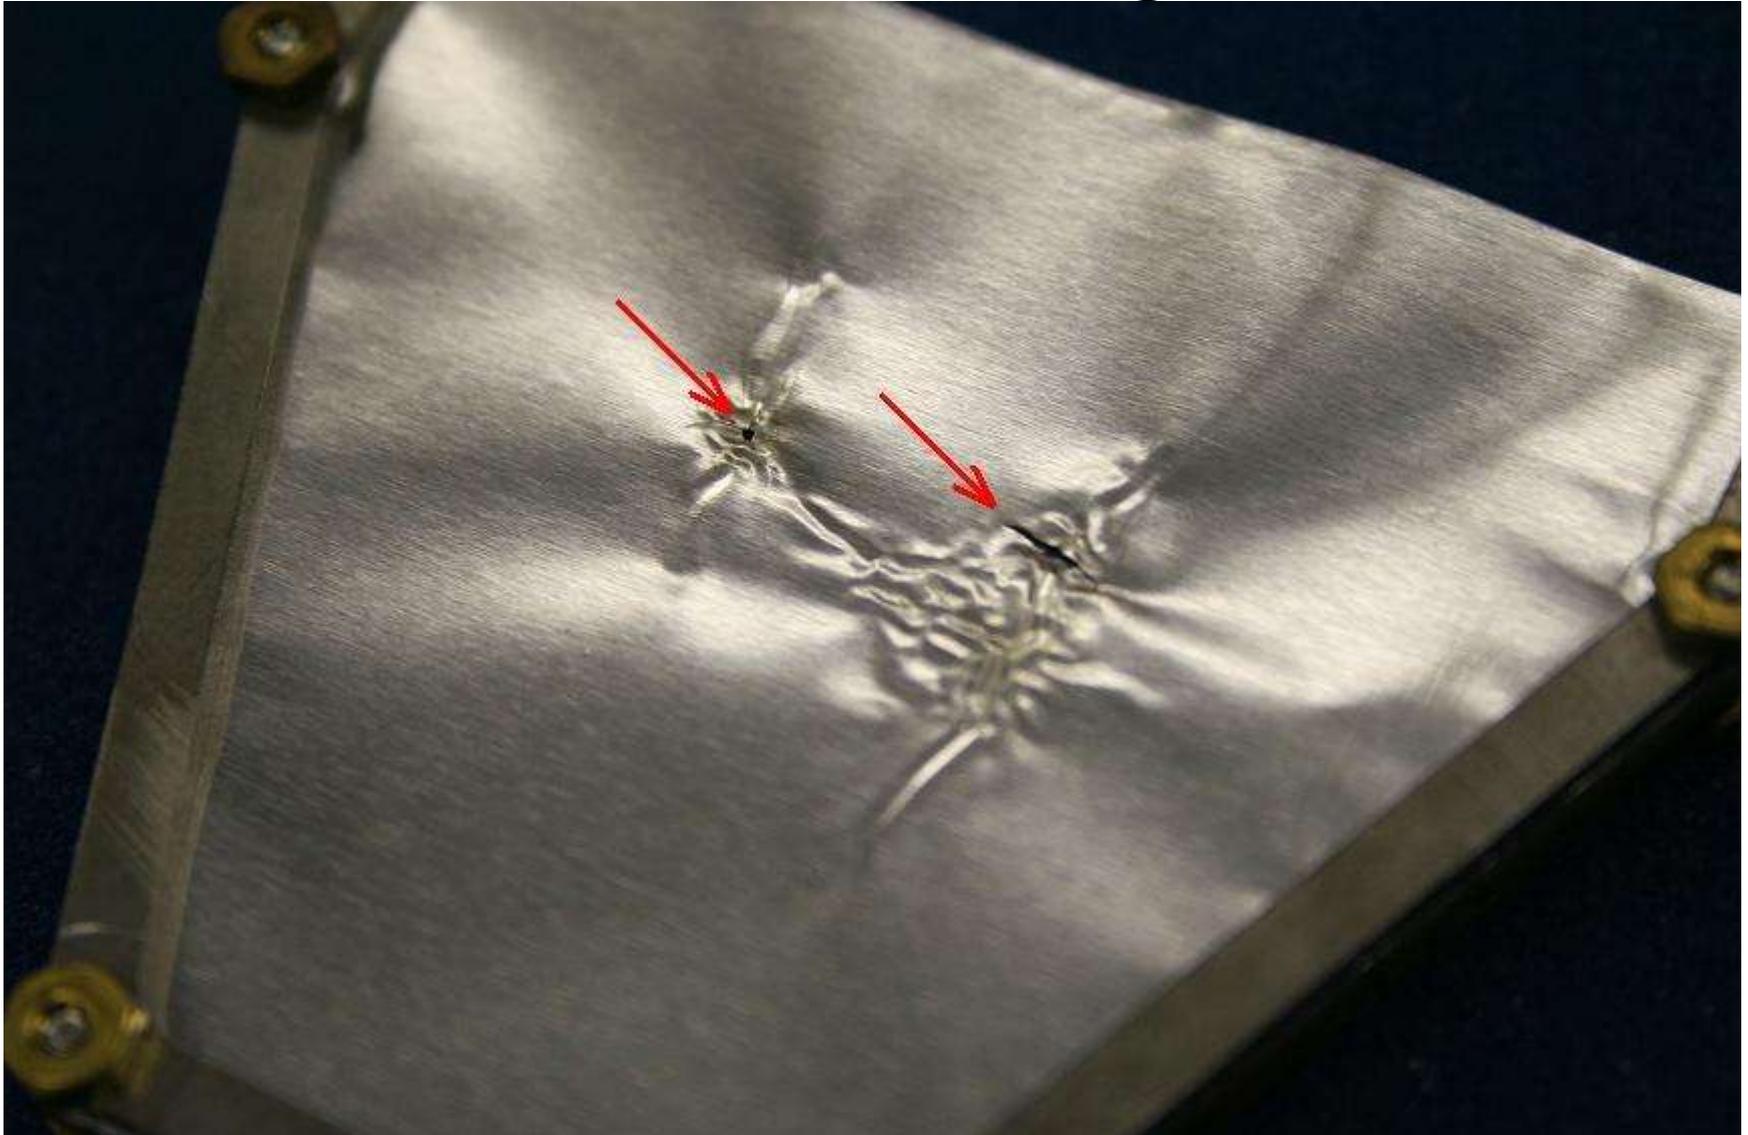
Old Foil #7 after taking it out. The arrows point to a small hole and to a large crack.

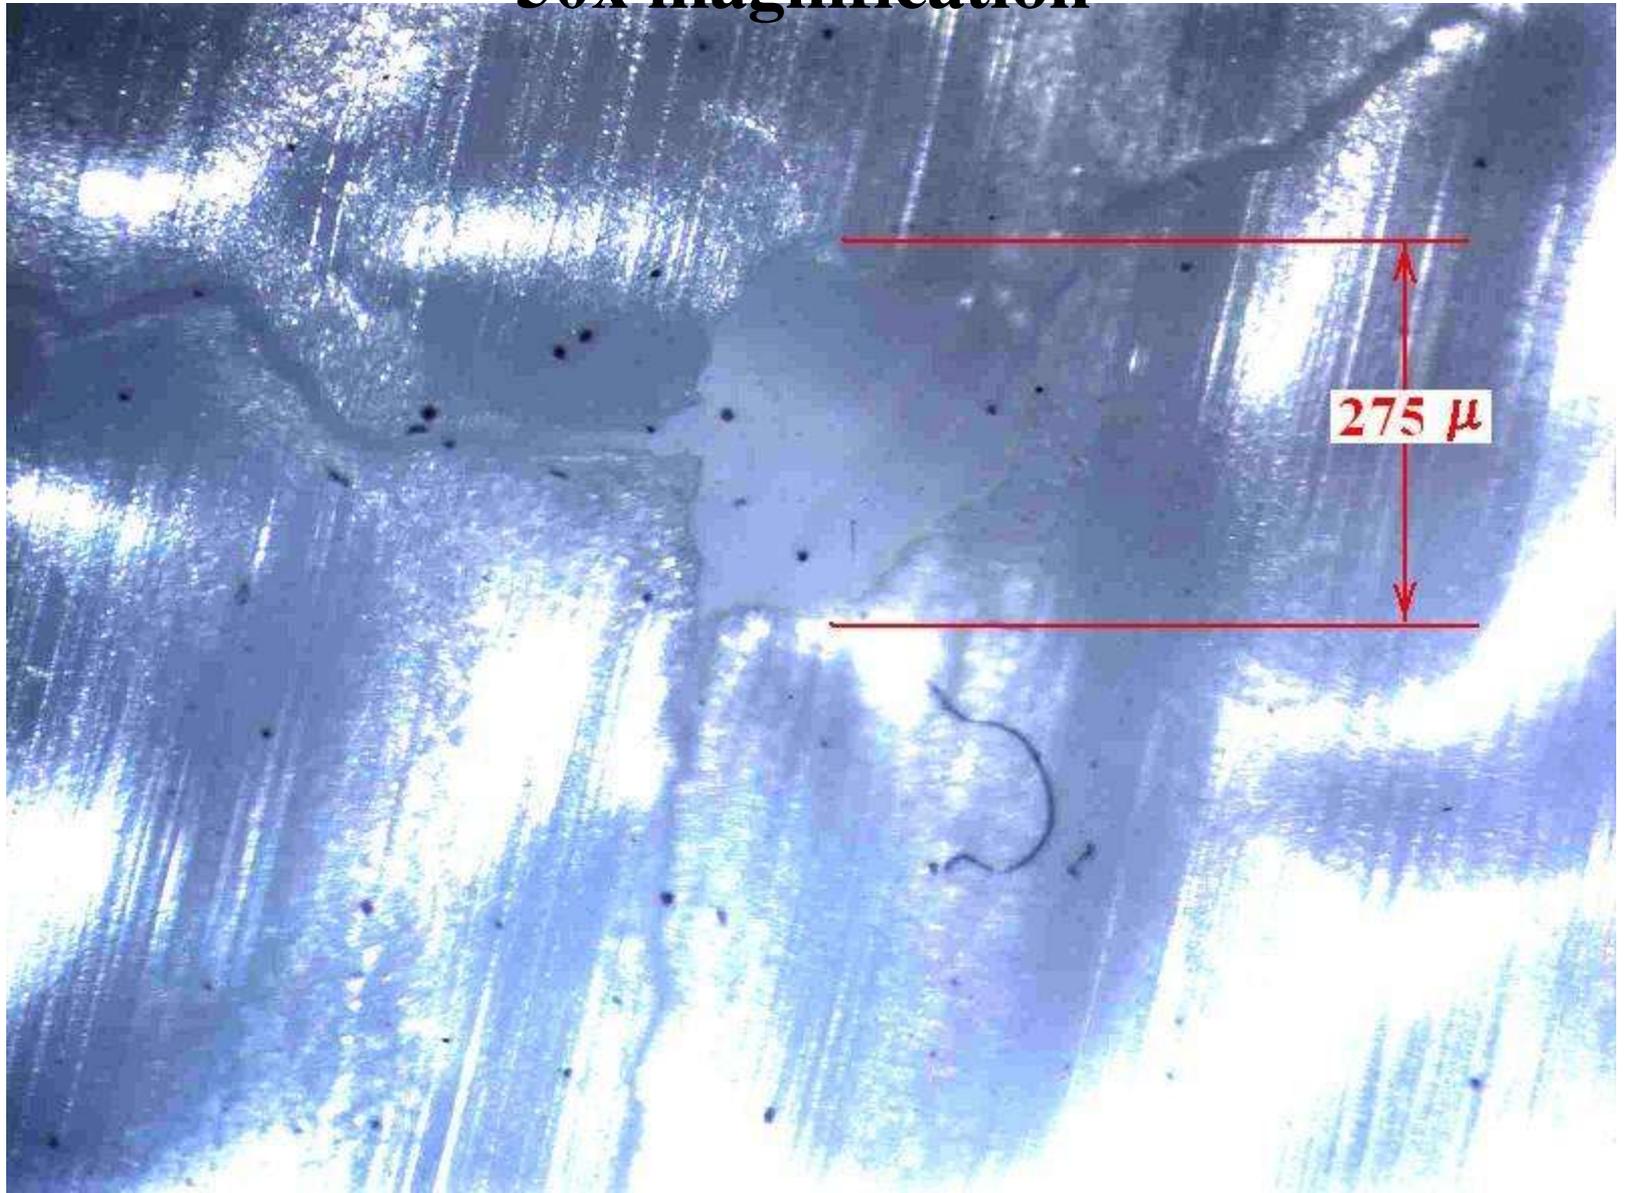
Cracks and 275 μ diameter hole recorded with 50x magnification

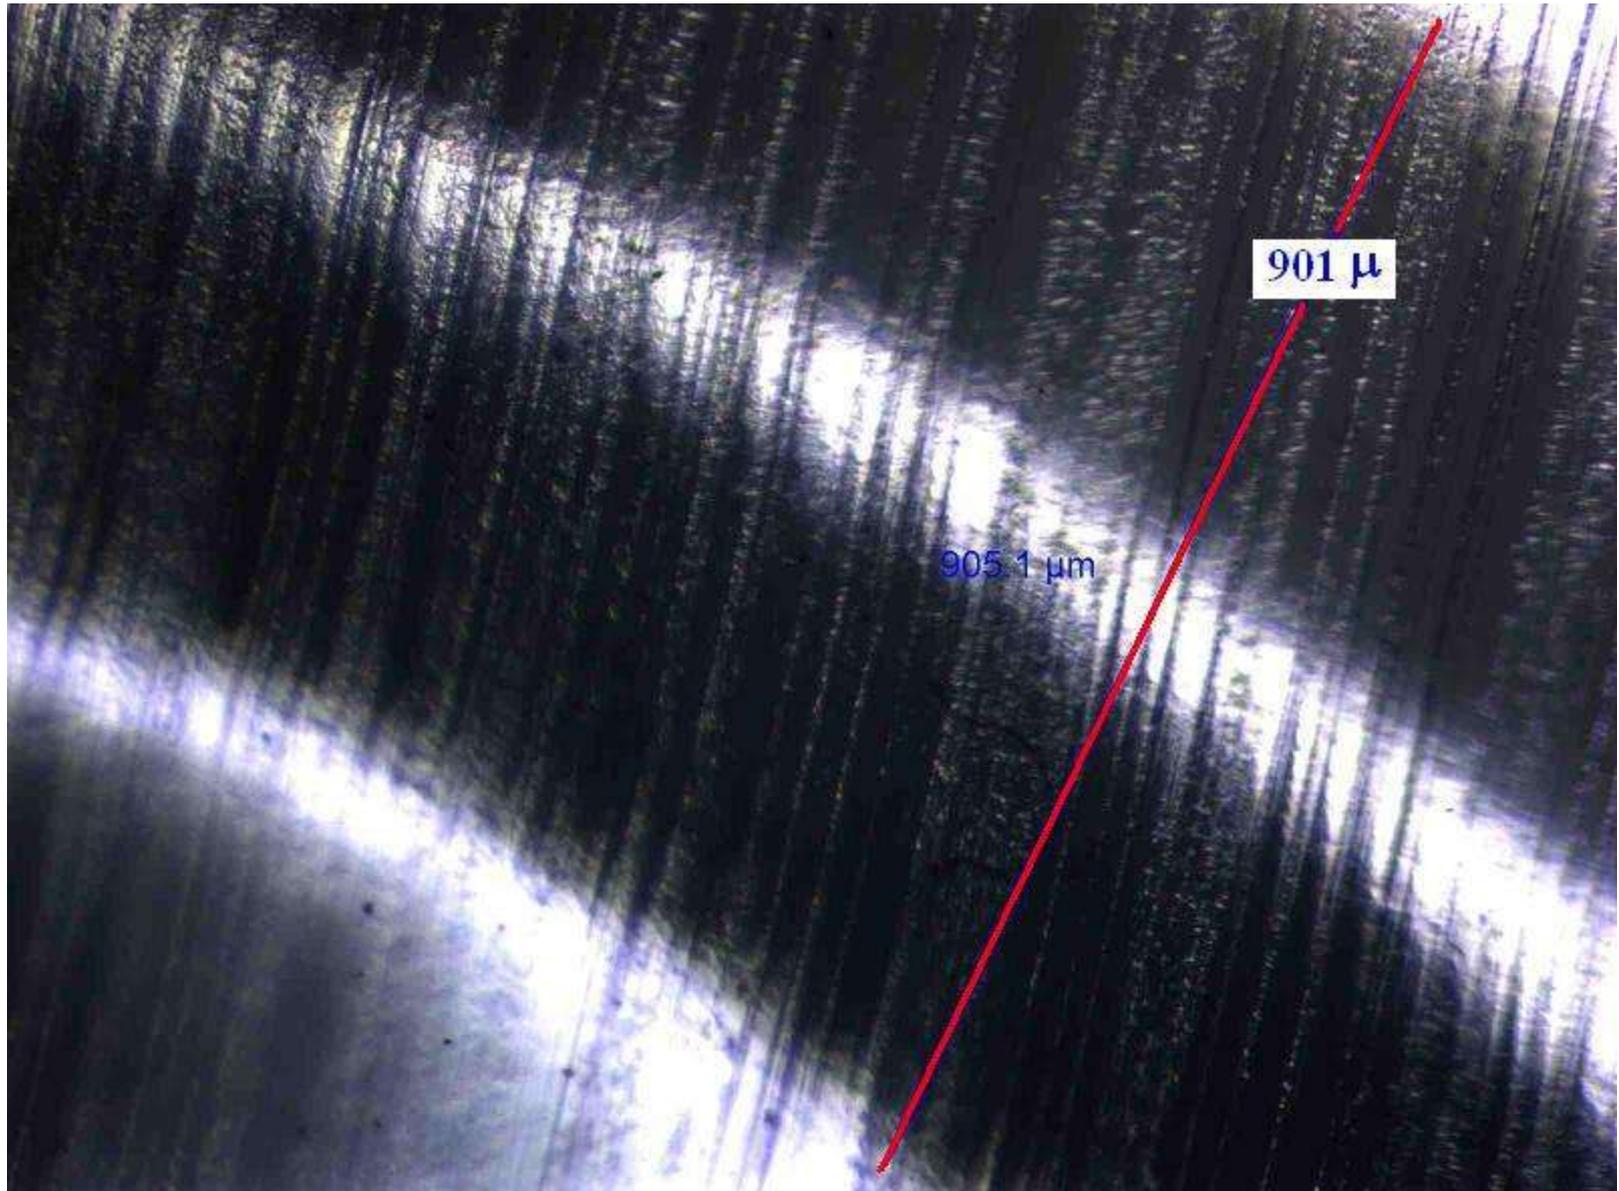
900 μ wide, 180 μ deep fold measured with 100x magnification. The central stripe is the crest, and the other two the valleys.

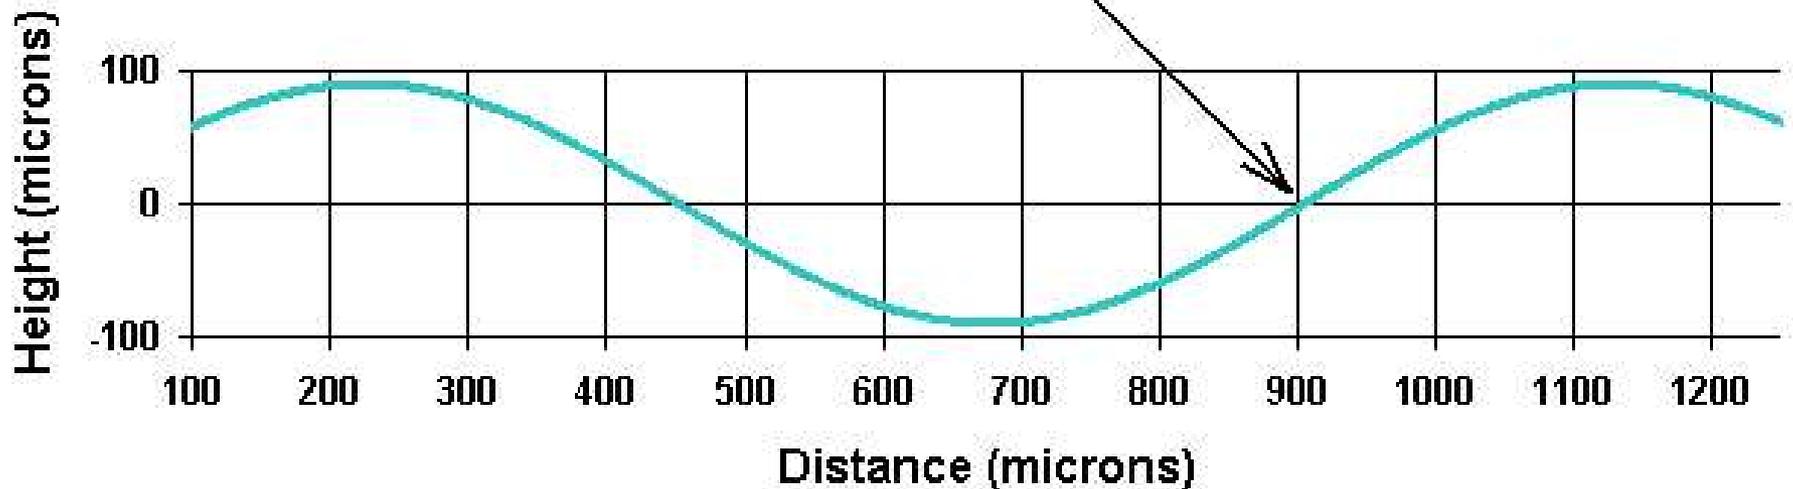
Sinusoidal approximation of the surface profile showing that the maximum variation in effective thickness is only $\sim 18\%$ i.e. $\pm 9\%$.

**~ 32 degree max. slope or
 $\sim 18\%$ max. thickness variation**
