date: October 23, 2003
to: E. Lessard; Chair, LESHC
from: Congwu Du, Micro-MRI Facility
subject: Summary of Responses to Safety Committee Comments

Date: November 28, 2003
To: W. Gunther
From: R. Karol
Subject: Medical Department Animal MRI ODH Calculations

subject: **Operational Readiness Evaluation (ORE) Report – Building 490, Micro MRI Facility, Full Operation**

(BUILDING 490, MICRO MRI FACILITY, FULL OPERATION)

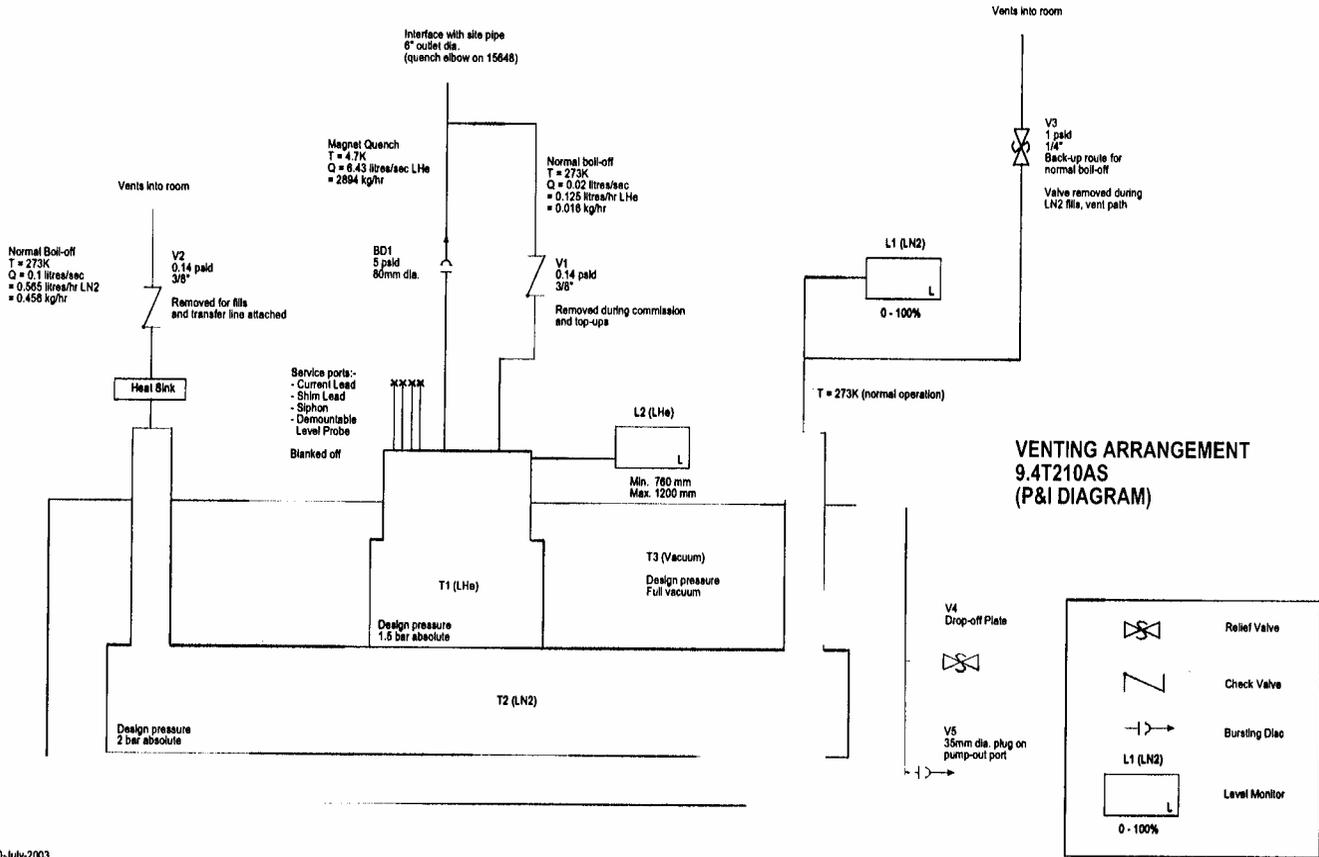
The attached figure shows the normal venting flow rates of nitrogen and helium (Venting Arrangement 9.4T210AS, P&I Diagram dated 30-July-2003). Converting routine boil-off to gas volume rates at 300 K room temperature, results in 0.06 CFM helium gas and 0.24 CFM nitrogen gas inputs into the room, which is a total of 0.3 CFM of inert gas. This is obviously so small that the room's oxygen concentration will never fall below 21% with EF2 operating. In fact it would take over 6 days for the room to fall to 19.5% oxygen if the fan were off and it was assumed that no fresh air were to enter the room. Thus for normal operations, no ODH classification is required.

The attached figure shows the quench venting flow rate for helium (Venting Arrangement 9.4T210AS, P&I Diagram dated 30-July-2003). The figure shows that 2894 kg/hr of helium are released during a quench event. Converting this to helium gas at 300K results in an enormous spill rate of 10,464 CFM. This far exceeds the exhaust fan flow rate of 1000 CFM. The total volume of LHe in the magnet is 1050 L (37.1 ft³). Using the expansion factor of LHe (4.2K) to GHe (300K room temperature) of 768 results in a total volume of 28,493 ft³ GHe. Thus the room's oxygen concentration would rapidly fall to 0% if the quench vent pipe failed.
