AGS STUDIES REPORT

Reported by W. Weng

Subject The H5 Kicker Test

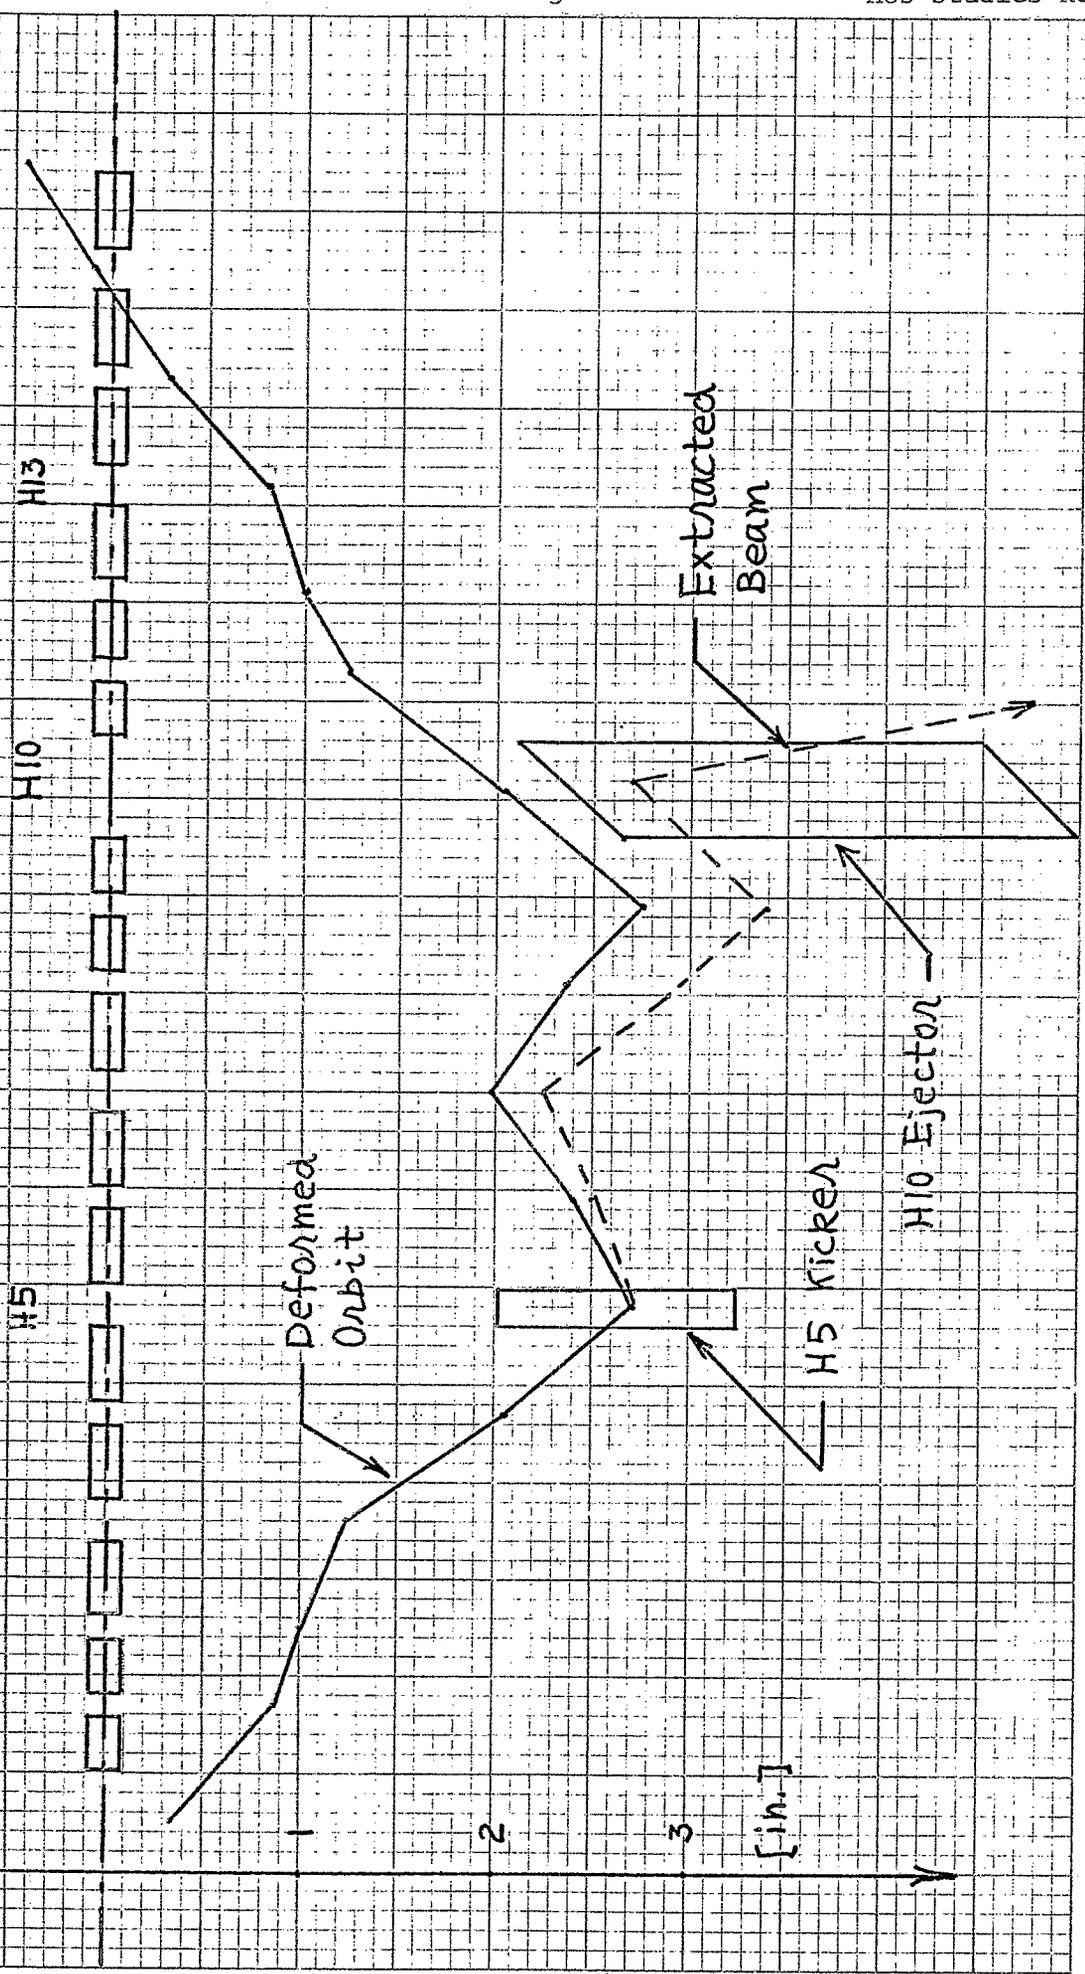
Fig. 1. H5-FEB Extraction Trajectory

The designed central orbit of the deformed beam had been calculated and plotted in Fig. 1. The beam position at H5 s.s. is 2.7" and at H10U and H10D are 2.3" and 1.7" respectively. The edge of the H5 kicker was surveyed in at 2.06". With the good field region of the H5 kicker starts at 0.2" inside the edge of the ferrite and beam half width 0.35", the beam center point should be at $2.06 + 0.2 + 0.35 = 2.61$ " as desired. The position of the H10 ejector was set to be 2.65" U and 2.1"D respectively.
