**Fire Hazard Analysis  
Building 923  
Accelerator Department  
Electronic Equipment Repair**

**Brookhaven National Laboratory**

Date of Report: May 2007

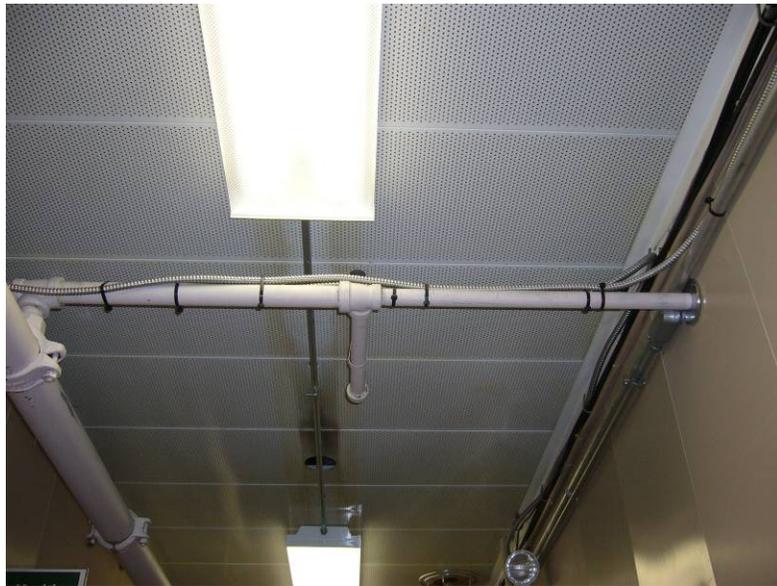
Photograph #1, Wiring on Sprinkler Piping

**Finding:** Wiring was observed attached to the sprinkler piping in the hallway as shown in Photograph 1.

Hazard Severity	IV
Mishap Probability	D
Risk Assessment Code	6

**Recommendation HAI-06-923-01:** Remove the wiring from the sprinkler system piping [NFPA 25, Section 5.2.2.2] (See Section 5.1.3).

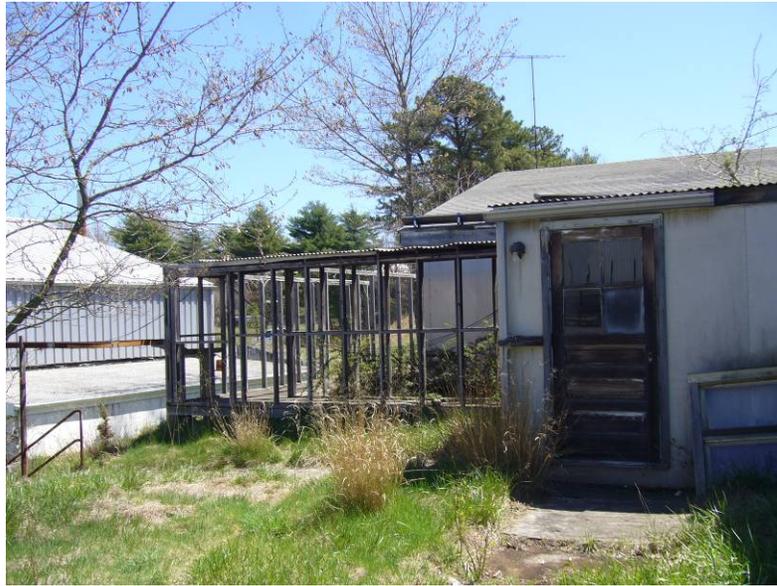
Photograph #2, Rear Structure

**Finding:** An exposed wood stud structure is located on the north end of the building (See Section 6.3)

Hazard Severity	III
Mishap Probability	C
Risk Assessment Code	4

**Recommendation HAI-06-923-02:** Remove the exposed wood stud addition on the north end of the building (See Section 6.3).

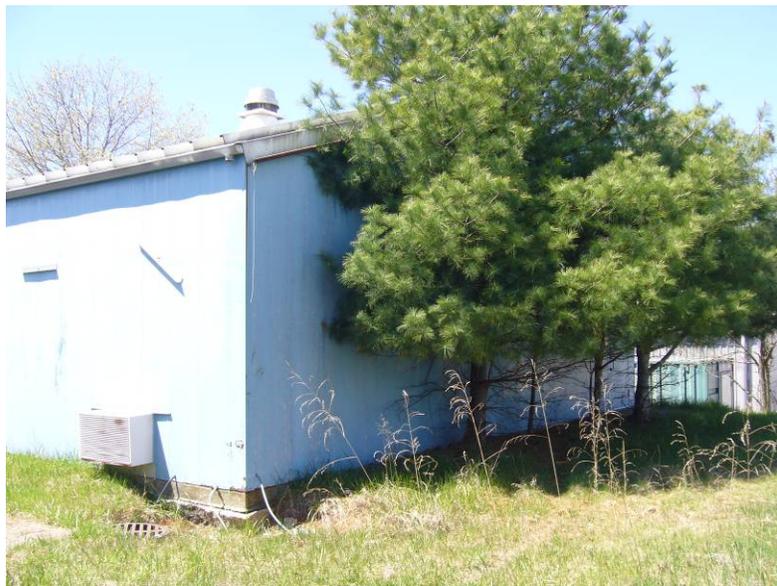
Photograph #3, Pine Trees

**Finding:** Two pine trees are located on the north side of the building and pose an unnecessary exposure to the building (Photograph #4) (See Section 6.4.1.1).

Hazard Severity	III
Mishap Probability	C
Risk Assessment Code	4

**Recommendation HAI-06-923-03:** Remove the pine trees.

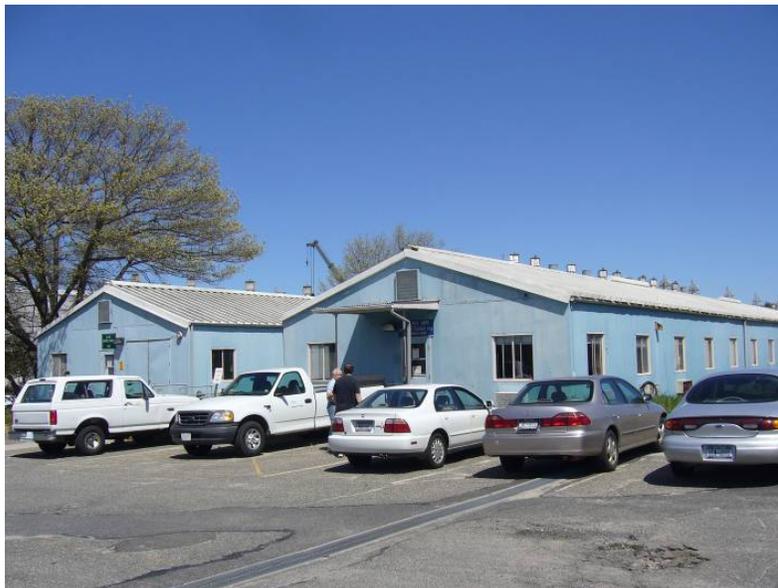
Photograph 4 – View of South End of Building 923 from Parking Lot

Building 923 is a one-story building constructed of insulated metal panels on steel frame. A wood frame addition is located on the north end of the building which connects to a small room used for the storage of electronic equipment. This addition is sided with asbestos transite panels. With the exception of the north addition, the overall building is classified as unprotected and noncombustible construction; BCNYS Type IIB and NFPA Type II (000).

The building consists of two “wings” approximately 30 feet wide by 165 feet long connected by an enclosed walkway in the middle. The wings of the building have peaked roofs with a height of approximately 15 feet with 10 foot eaves (Photograph 1).

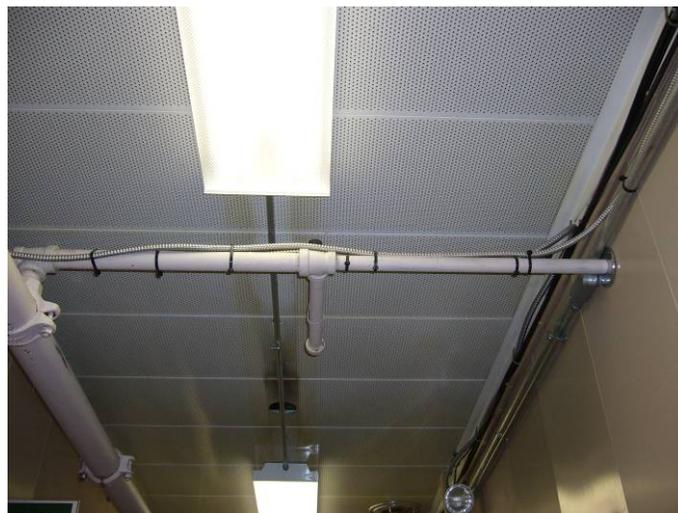
## Photograph 1 – Wiring Attached to Sprinkler Piping

Wiring was observed attached to the sprinkler piping in the hallway as shown in Photograph 1 (**Recommendation HAI-06-923-01**).

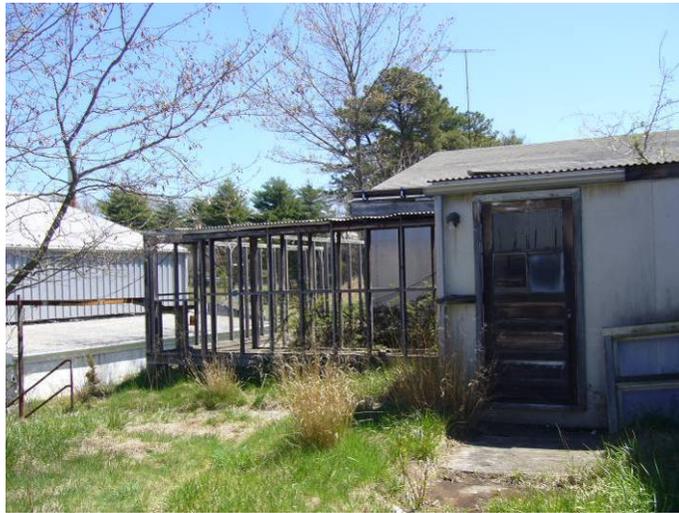
Photograph #2 – Wood frame structure at north end of Building 923

There are no trailers or portable structures associated with Building 923. However, there is an electronic equipment storage room on the north side of the building that is attached to Building 923 by a wood frame construction walkway (Photograph #2). In addition, there is a portable storage unit located on the west side of the building, between Building 923 and Building 918.

The addition on the north end of the building is constructed of exposed wood studs (Photograph #2) (**Recommendation HAI-06-923-02**).

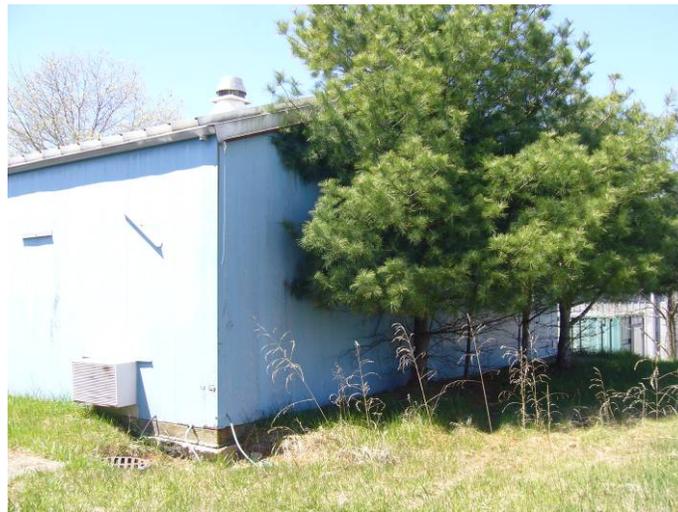
Photograph #3 – Trees at the north end of Building 923

Exposures to the North are minimal. Building 922 is located approximately 50 feet away. Two pine trees are located on the north side of the building and pose an unnecessary exposure to the building (Photograph #4) (See **Recommendation HAI-06-923-03**).

Based on the analysis, the hazard from wildfire to Building 923 is "LOW". Specifics of the Wildfire Hazard Severity Analysis are shown in Appendix C of this report. However, two pine trees located at the north end of the building present an exposure (Photograph 4).

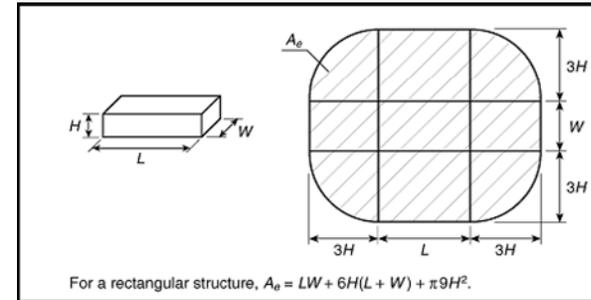
Figure H.4.2(a) Calculation of the equivalent collective area for a rectangular structure.

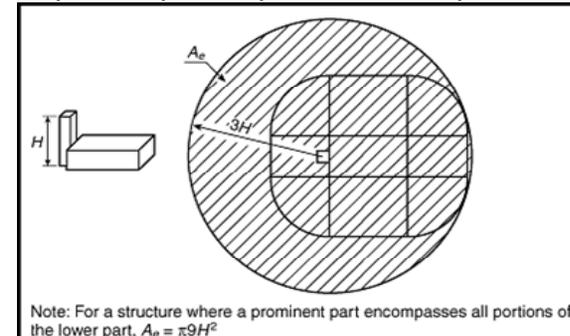
Figure H.4.2(b) Calculation of the equivalent collective area for a structure where a prominent part encompasses all portions of the lower part of the structure.
