Fire Hazard Analysis
Brahms Experimental Hall
Buildings 1002, 1002-A, 1002-B, 1002-C and 1002-D

Brookhaven National Laboratory

Date of Last Survey: September, 1998
Date of Report: August, 2007

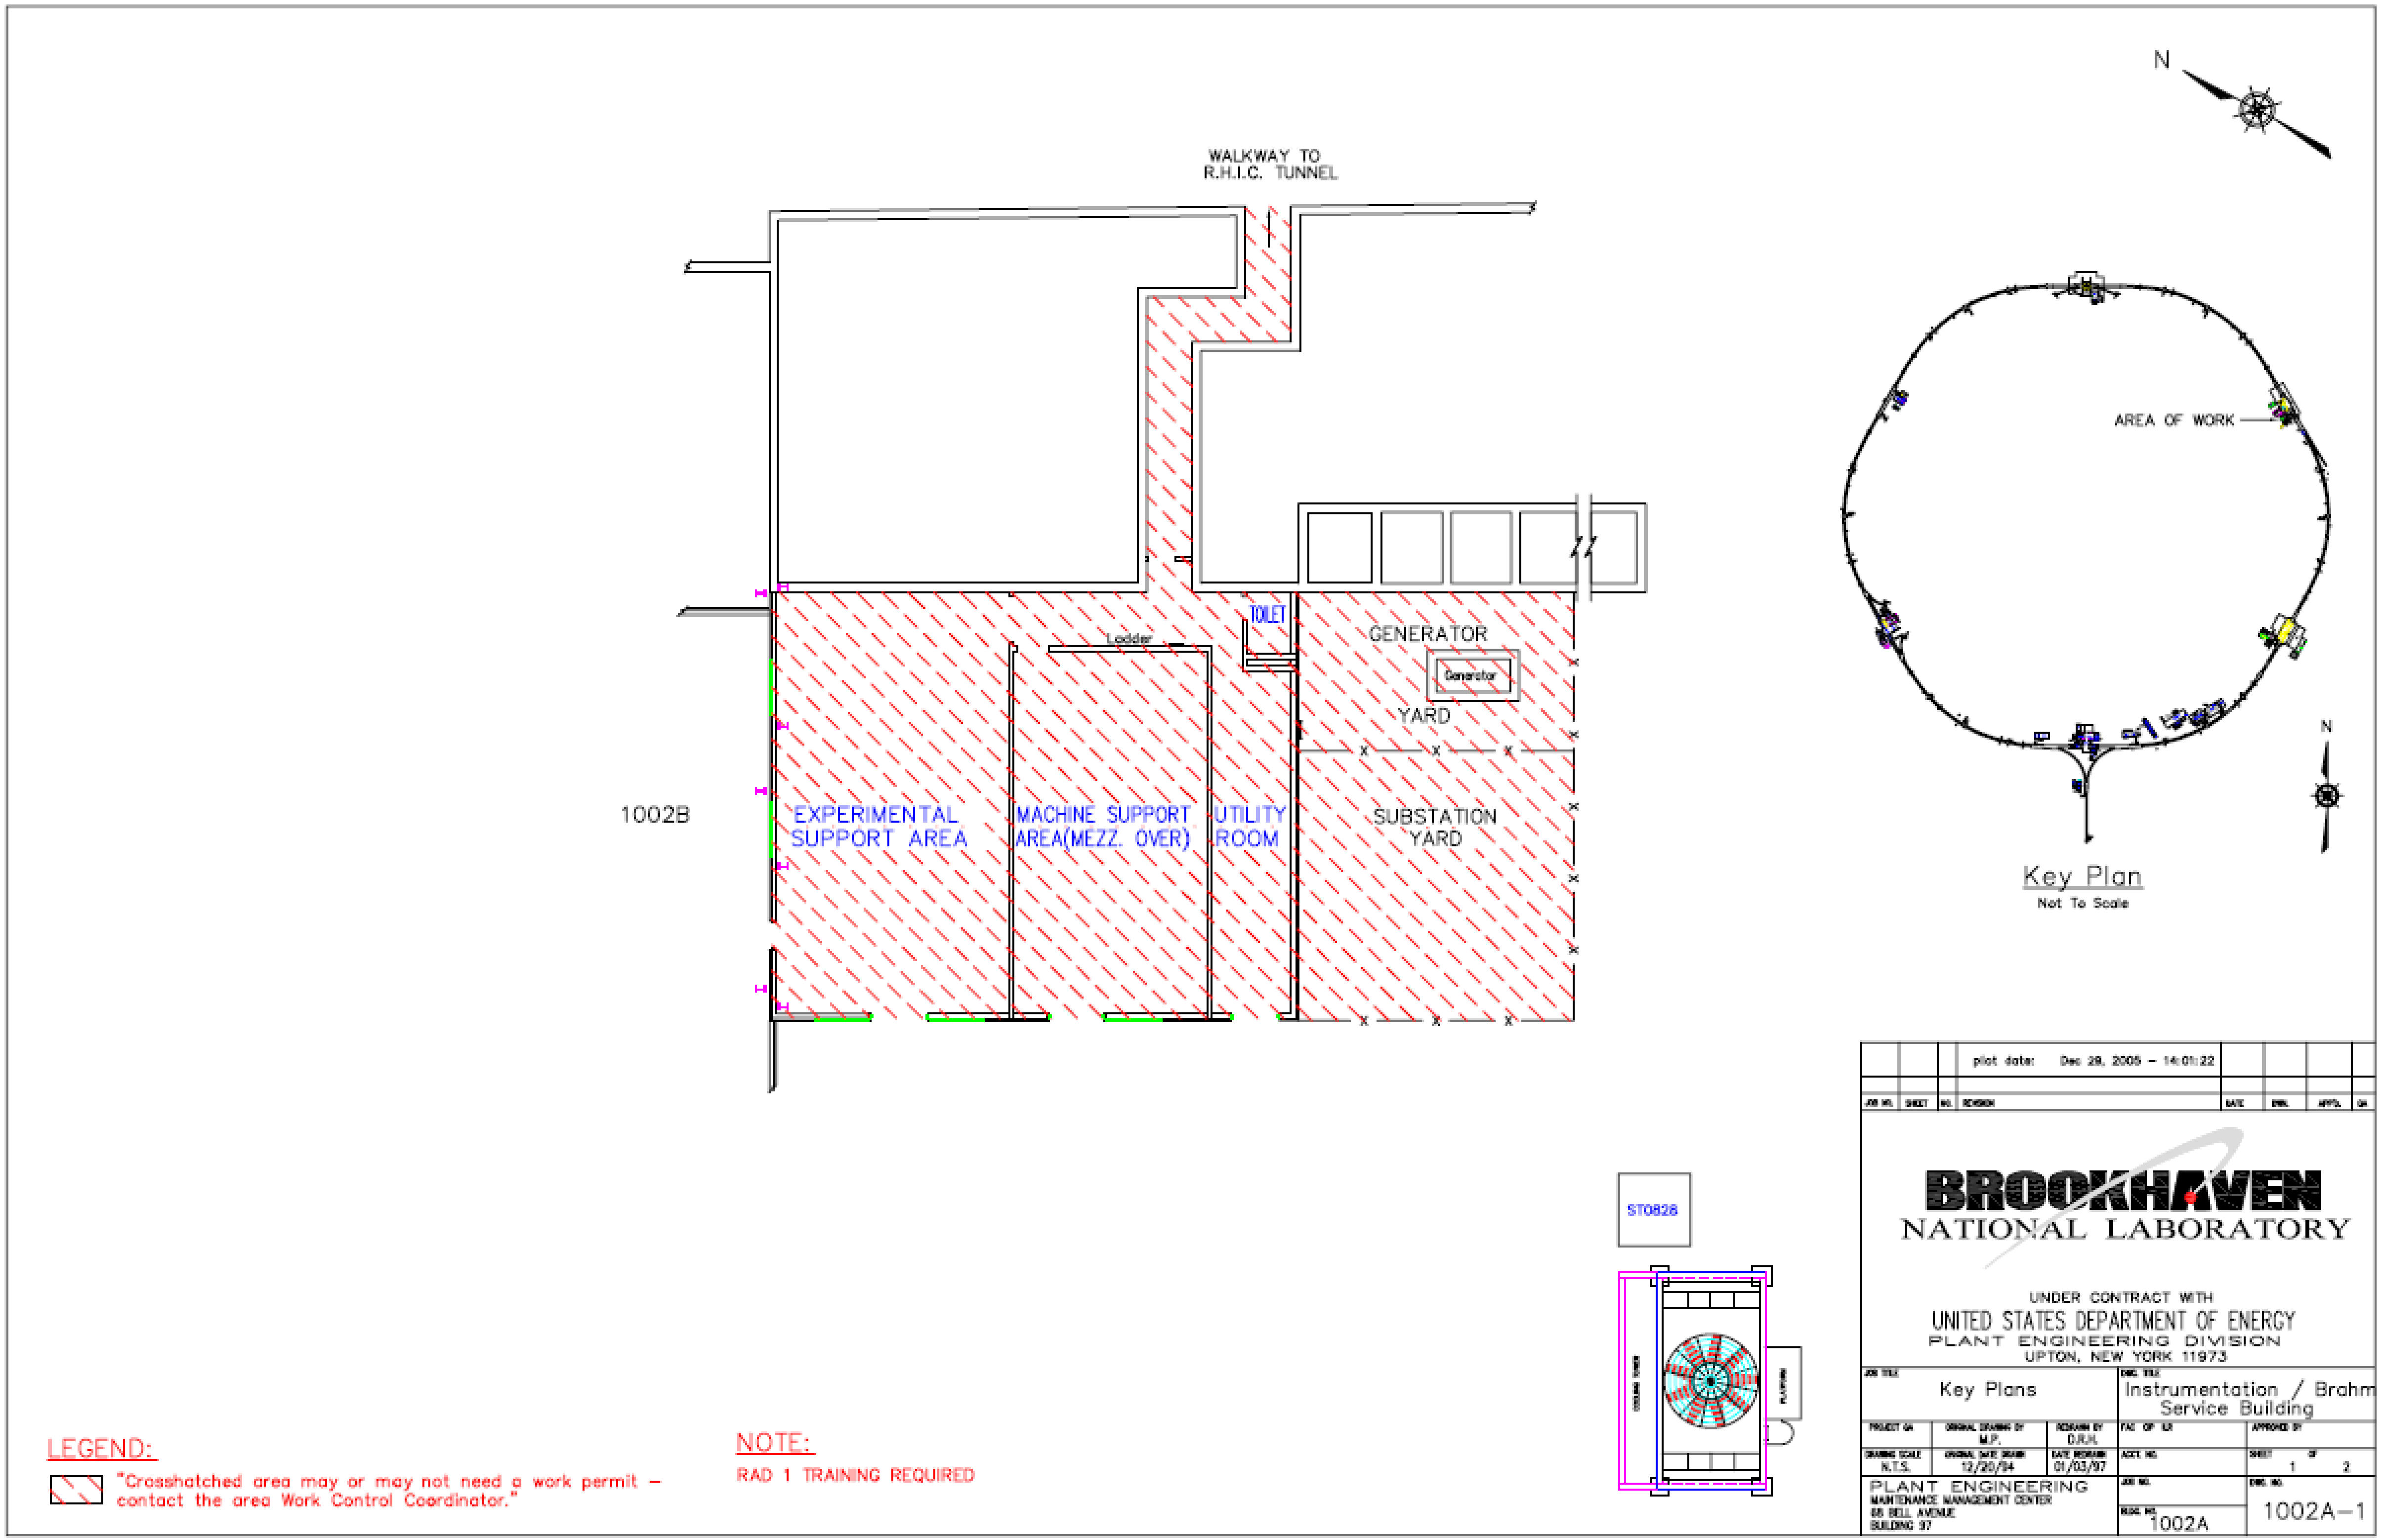
Finding: The experimental support area in the northeast corner of Building 1002A, Instrumentation/Service Building is not protected by the buildings automatic sprinkler system.

The Brahms Instrumentation/Service Building machine support area, mezzanine and utility room are provided with automatic pre-action sprinkler protection in accordance with NFPA 13. The experimental support area in the northeast corner of the building is not protected by this system (**See Recommendation HAI-07-1002A-01**). Waterflow alarms are connected to the building fire alarm system. Sprinkler valve supervision reports through the Site Fire Alarm System as supervisory devices.

Recommendation HAI-07-1002A-01: Automatic sprinkler protection should be extended from the building system to provide coverage for this area of the building (See Section 5.1.3).
