Accelerator Department
BROOKHAVEN NATIONAL LABORATORY
Associated Universities, Inc.
Upton, New York

AGS DIVISION TECHNICAL NOTE

No. 99

SIEMENS POWER SUPPLY MOTOR-GENERATOR SET
MOTOR ROTOR FAILURE

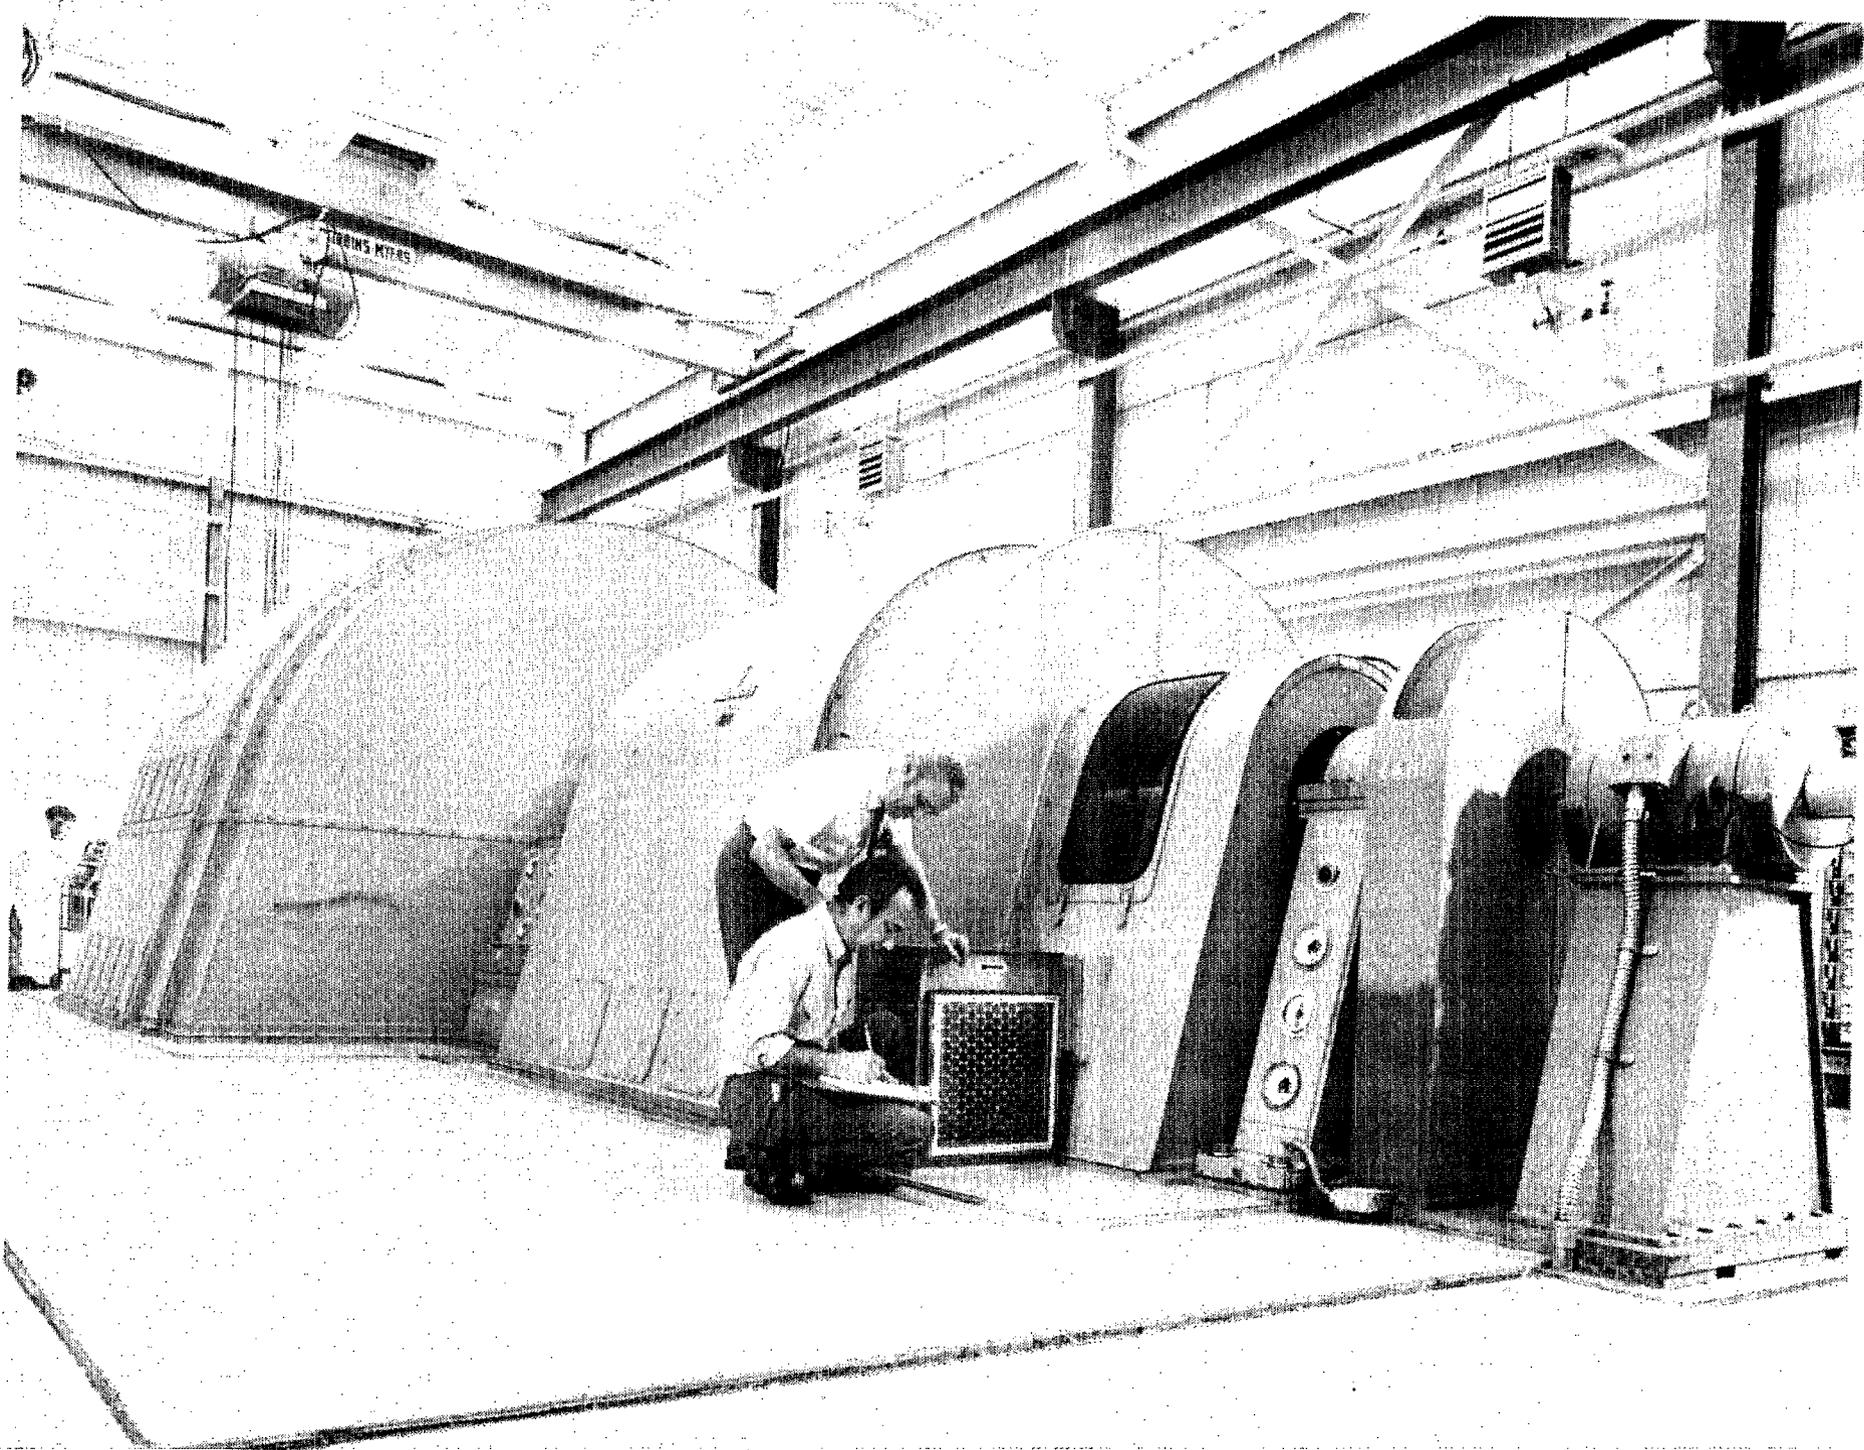
Fig. 1

The Siemens power supply is used to power the 33 GeV Alternating Gradient Synchrotron main magnet. It consists of a motor-generator set (Fig. 1) supplying energy to banks of mercury-arc rectifiers through transformers. The motor is a wound-rotor induction motor rated at nine megawatts, 13800 volts, 3 phase, 60 hertz, 1200 rpm. The generator is rated at 50 MVA continuous 95 MVA surge, 7500 volts, 3 phase. The power supply output is 12000 volts, 7000 amperes, pulsed duty.
