**Fire Hazard Analysis
Building 913
AGS Tunnel**

Brookhaven National Laboratory

Date of Last Survey: None on record
Date of Report: March, 2007

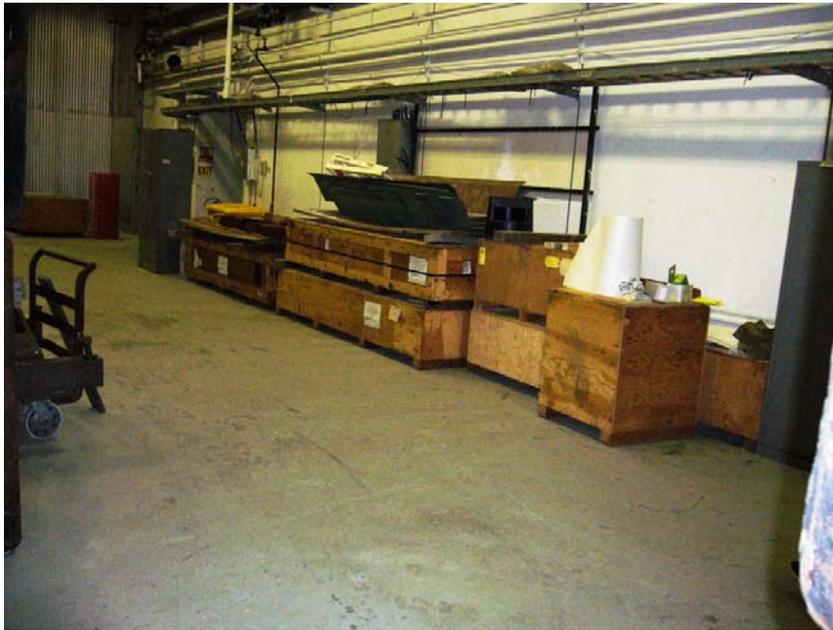
Photograph #2 – Excess Combustibles

Good housekeeping and control of combustibles was observed during this survey, except as noted at the North conjunction area at J-1 (refer to recommendations). The Collider-Accelerator department self-inspection program (Tier I) monitors routine experimental aspects. The BNL Plan Review Process screens conventional construction operations.

The tunnel is considered one fire area and thus a single MPFL calculation is being performed. The area contains the equipment for the AGS Tunnel, and the amount and continuity of combustible material is low, with the exception of the North Conjunction Area that has excessive combustibles (refer to recommendations).

Recommendation HAI-06-913-03: The combustibles should be removed.

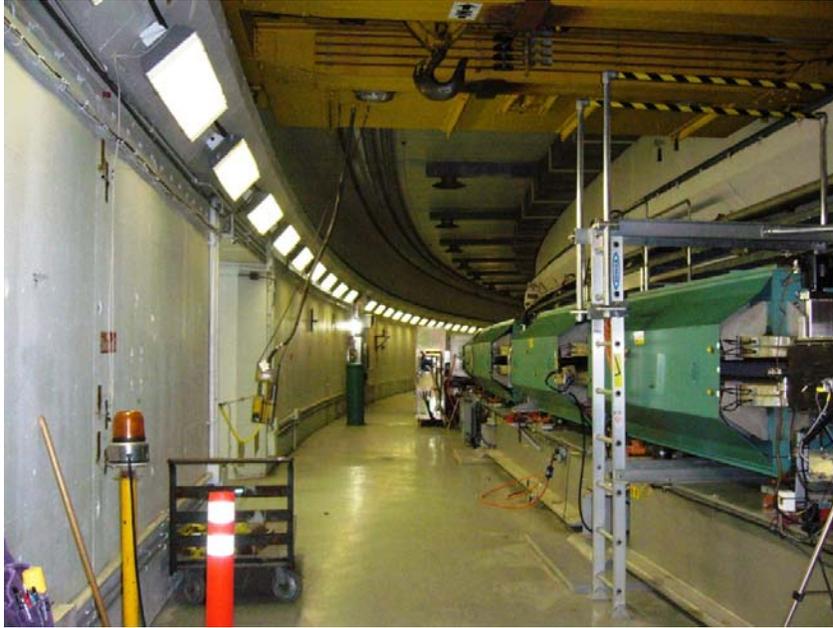
Photograph #3 – Building 913 – Tunnel Interior

There are six level steel cable trays with approximately 50% fill located along the tunnel wall at approximately 3 to 4 feet from the floor. The cables are AC/DC power cables and signal/control COAX. The cable trays are provided with bags of vermiculate every 15 - 20 feet to act as a fire stop in the event of a cable tray fire. According to local facility personnel, the effectiveness of the bags has no technical basis and thus their use has not been continued at the BNL. This is consistent with what is found in the RHIC tunnel. At this time a recommendation is not being submitted to substitute these bags for a different form of cable tray protection, refer to Section 4.3.1 for further discussion.

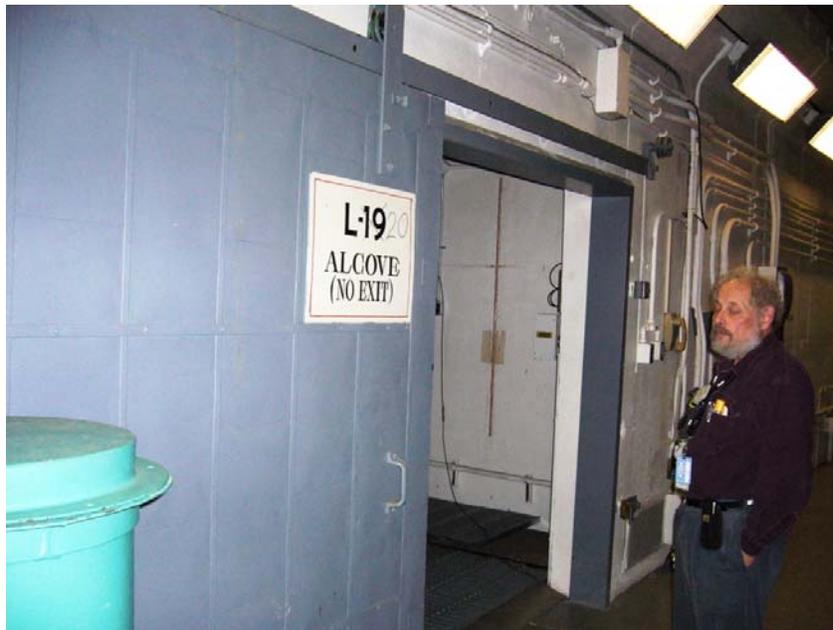
Photograph #4 – Sliding Fire Door at L-20 at Alcove

There is a sliding Class A fire door at the L-20 Alcove.

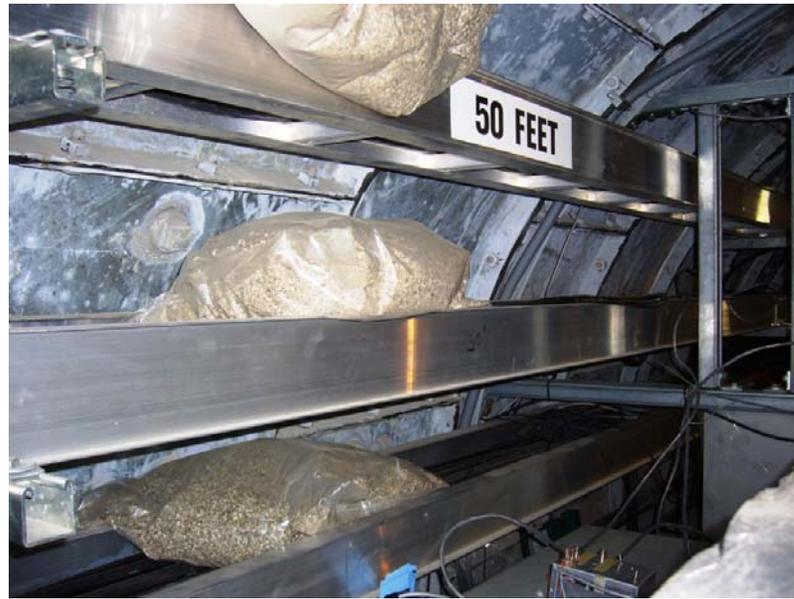
Photograph #5 – Example Vermiculite Bag on Cable Trays (from Building 909)

Polyethylene bags containing vermiculite are positioned on cables throughout the AGS tunnel. According to local facility personnel, the effectiveness of the bags has no technical basis and thus their use was not continued in the un-protected section of the tunnel. This is consistent with what is found in the RHIC tunnel. At this time a recommendation is not being submitted to replace the vermiculite bags with a listed cable fire stopping product for the trays in the entire tunnel. This is based on the relatively low fill of the trays and the fire detection in the tunnel.

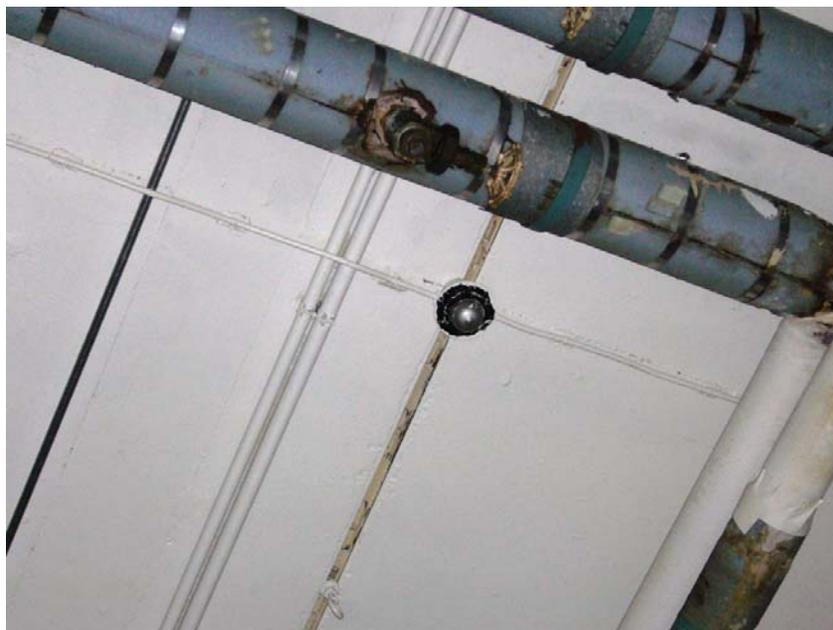
Picture #6 – Spot-Type Non-Restorable Heat Detectors

- Old style spot-type non-restorable heat detectors spaced at approximately 60 foot intervals with a few Fenwal rate compensated heat detectors at a few locations.
- Newer style heat detectors located between Magnet B-12 to J-17.
- Newer style heat detectors at G-19 to I-2.
- From G-1 to H-3, there is a section with a lower ceiling that has the heat detectors along the wall and not at the ceiling (refer to recommendations). The wall mounted heat detectors will not be as effective in this area. They are located at G-3, G-5, G-7, G-10, G-13, and G-15.
- The south entrance is also provided with heat detectors.

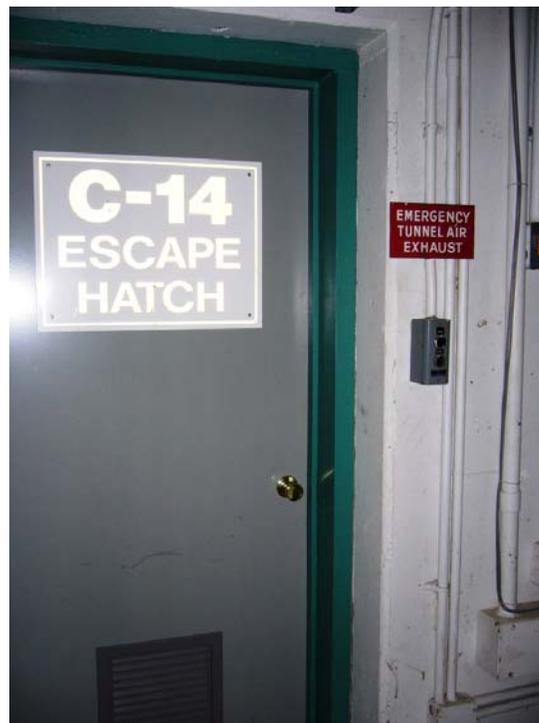
Picture #7 – Manual Tunnel Exhaust at C-14 Escape Hatch

The building is provided with a manual smoke exhaust system, with activation provided at each of the following exits:

- C-14 (that has an escape hatch)
- K-7
- I-5/I-4

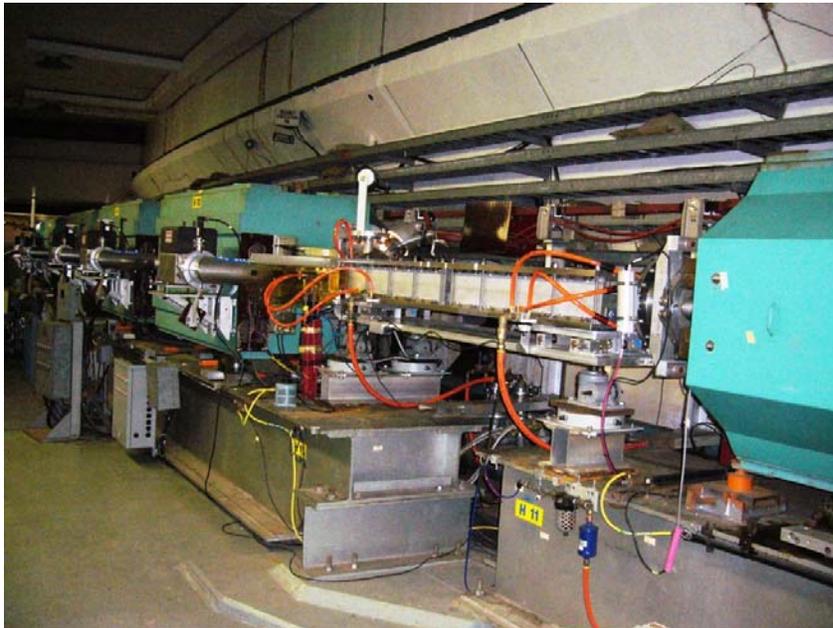
Photograph #8 – U Line Extraction Point

- RF Amplifiers are located at various locations throughout the tunnel
- The beams go into the RHIC tunnel and are extracted at the U Line, then to the XY line then to the Blue/Yellow rings at RHIC.
- A cold snake which is a super conducting magnet is located between A-20 and B-1, it is built by Magnet Division and is cooled with helium. It is a piece of high value equipment.
- At L-20 the beam enters from the AGS Booster.
- There is a scrapper located at J-11 that is capable of moving the beam.
- There is an idle warm snake located between I-10 and I-11 that is capable of acting as a solenoid.
- The U line extraction point is at located H-10.
- The slow extracted beam located at G-2 is out-of-service.
- A warm snake is located between F-20 and F-1 this is a DC dipole magnet that is helical and water cooled.

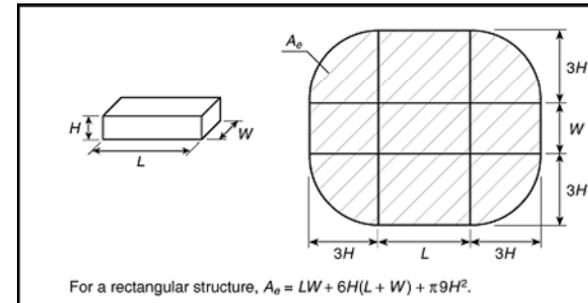
Figure H.4.2(a) Calculation of the equivalent collective area for a rectangular structure.

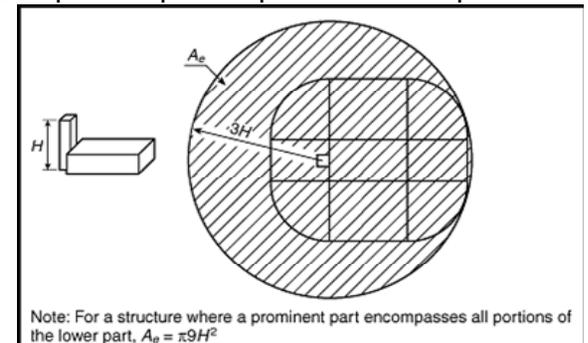
Figure H.4.2(b) Calculation of the equivalent collective area for a structure where a prominent part encompasses all portions of the lower part of the structure.
